CATCH CONTROL IN THE BLUE WHITING PELAGIC TRAWL FISHERY

Research Cruise Report [2022825]: FV "Vikingbank"

TOKTRAPPORT
No.1 2023

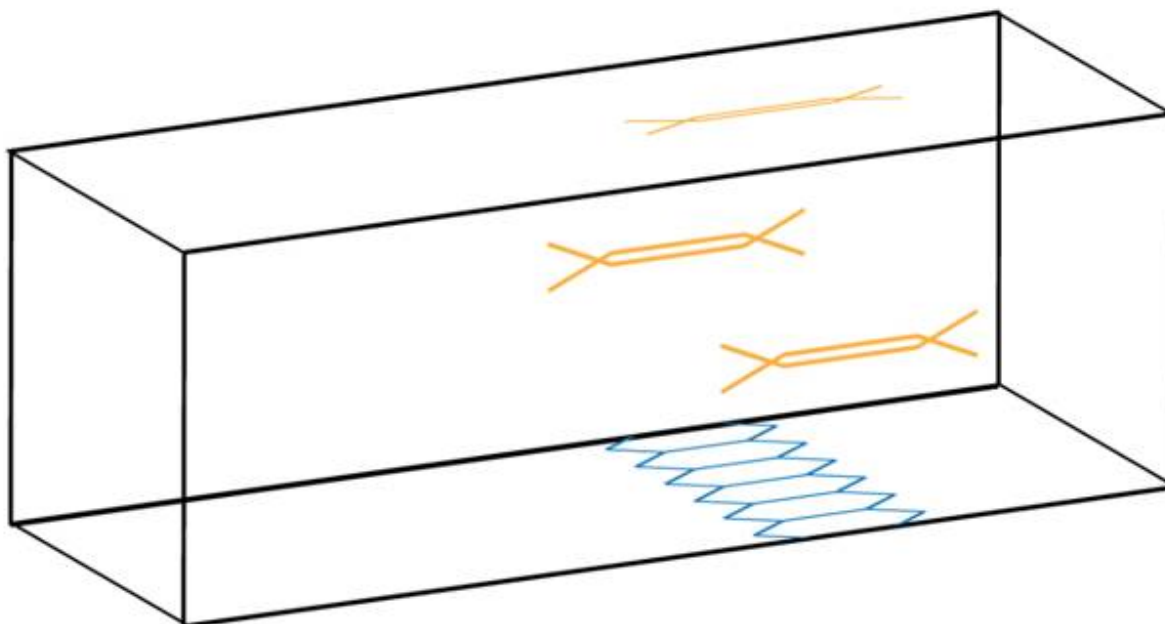
Figure 3.2 – Above: schematic diagram of 16m long fish release section (FRS) with 2.5m long slots on each of top and side panels and 2.7m Hexagonal Meshes in the bottom panel; for a detailed net drawing see appendix C.

The fish release section (FRS) used during this cruise consisted of a four-panel cylinder of netting, approximately 16m long, inserted between the trawl and cod-end, that incorporated two types of escape openings: 2.5m long slots on each of top and side panels and 2.7m Hexagonal Meshes in the bottom panel (figures 3.1 & 3.2). The distance from the openings to the cod-end was 6 m. The theoretical area of release openings: 18.9 m². The rig should allow free passage of the catch from the trawl into the cod-end during the fishing process, until the cod-end is full. The escape openings therefore should prevent escape during the normal fishing process, but once the cod-end is full should then enable fish to escape freely with minimal risk of crowding and abrasive injury.

When fitted to the trawl, the FRS appeared to be stable and adopt its designed geometry. The only exception was during the test hauls and hauls 01 and 07, when the bycatch release section (BRS) was attached. During these hauls it was noted that the vertical opening of the CLS during fishing was reduced by ~20% from ~2.5m to ~2.0m (table 2.2b).

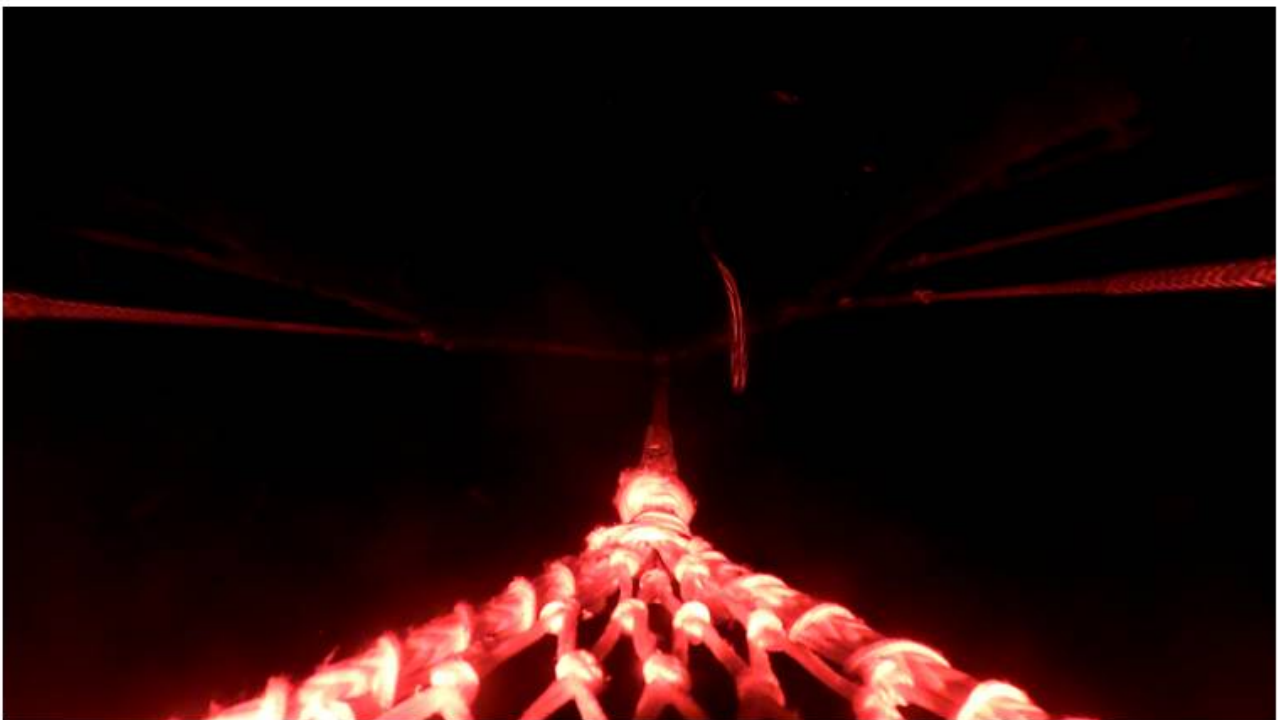
Figure 3.3 – Images from video taken during haul 11 at 01:38, just before the start of haul-back at 01:39. Top: from position 5iB looking aft toward the fish-lock and cod-end, showing medium densities of fish in the top of the FRS. Bottom: from position 4iB, looking aft over the escape opening, toward the fish-lock and cod-end, with three fish escaping. Note – the escape rate was approximately 12 fish/minute [01:38-01:39].

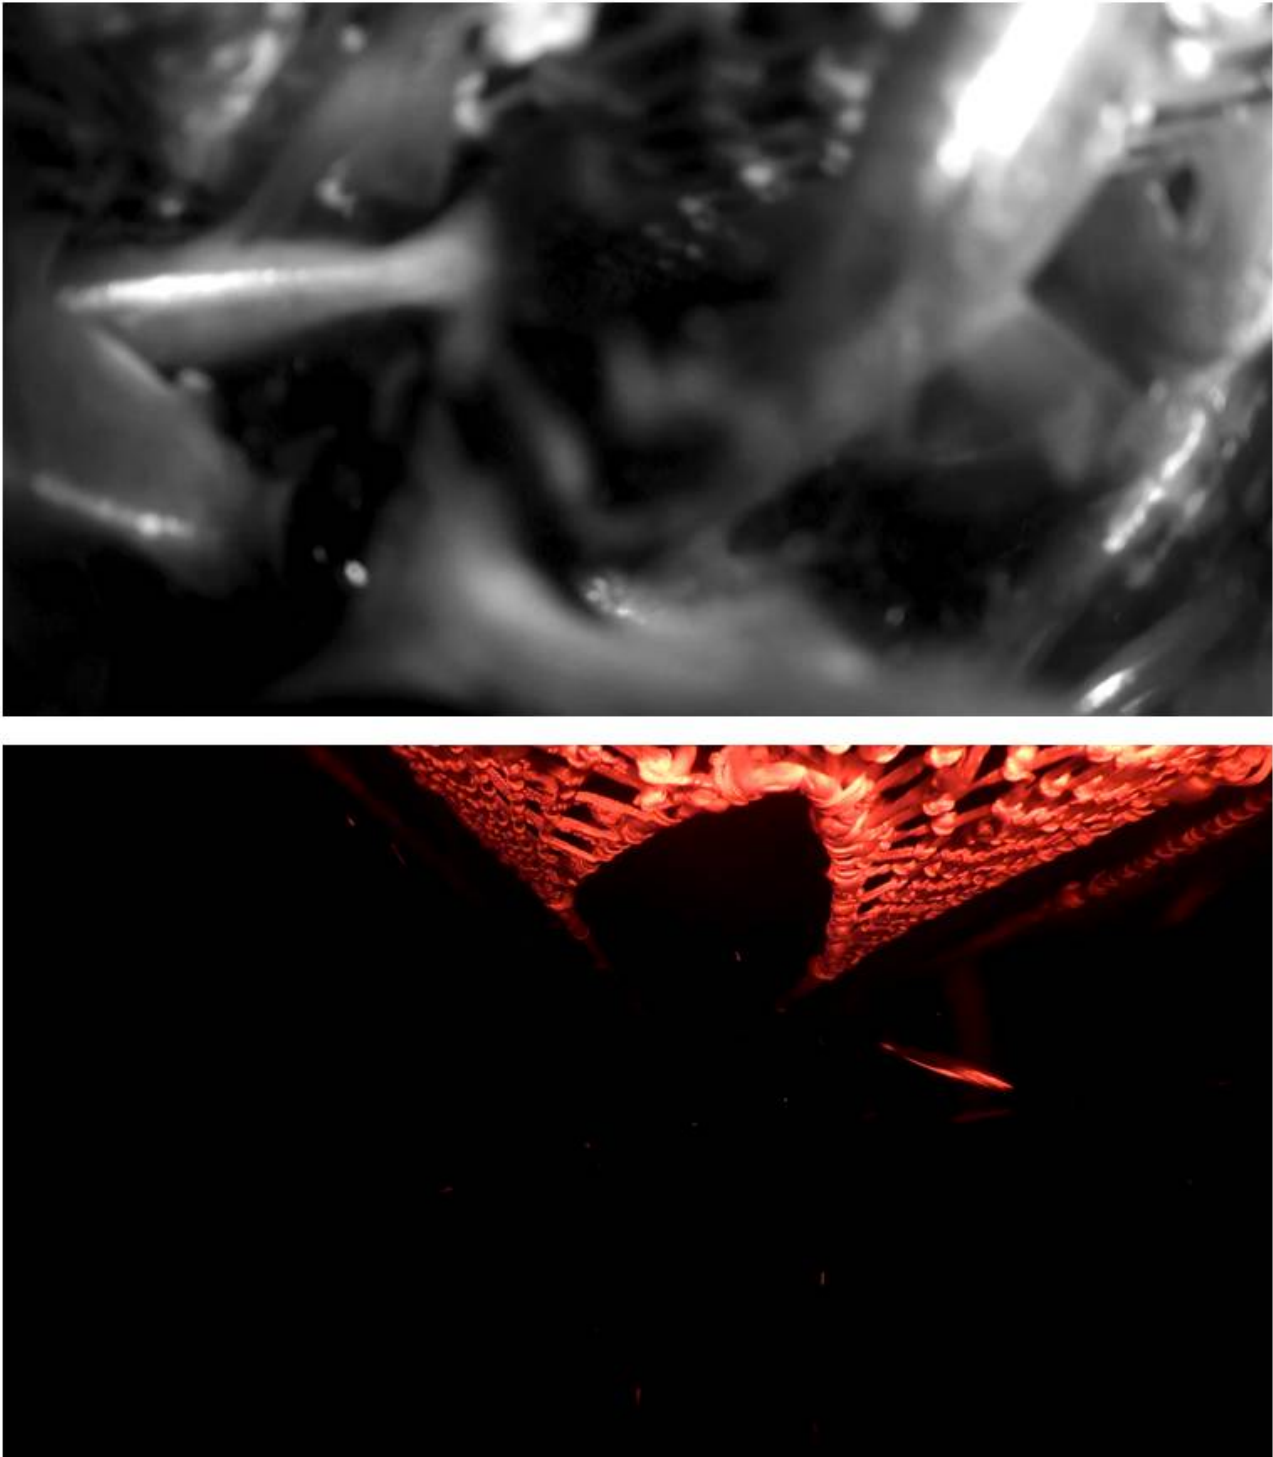
Figure 3.4 – Images from video taken during haul 05 at 21:19, approximately 1 hour before the start of haul-back at 22:24. Top: from position 5iB looking aft toward the fish-lock and cod-end, showing high densities of fish in the top of the FRS. Bottom from position 2oF, looking forward below the escape opening, with relatively few fish escaping, despite the high densities above. Note – the escape rate at this time was approximately 38 fish/minute [21:19-21:20].

densities were observed in the upper part of the FRS, there was a proportional increase in density in the lower part (e.g. figures 3.4 & 3.5).

While fishing, the FRS allowed fish to pass easily into the cod-end. Furthermore, the observed behaviour pattern of blue whiting, i.e. fish predominantly congregating in the upper part of the FRS, facilitated minimal escape of this target species through the release opening in the bottom panel. At low to medium densities in the upper part of the FRS, which were the most prominent catch densities observed, the typical escape rate was 0 to 15 fish per minute (figure 3.3). While at high densities, escape rates of between 23 and 65 fish per minute were observed (figures 3.4 & 3.5).

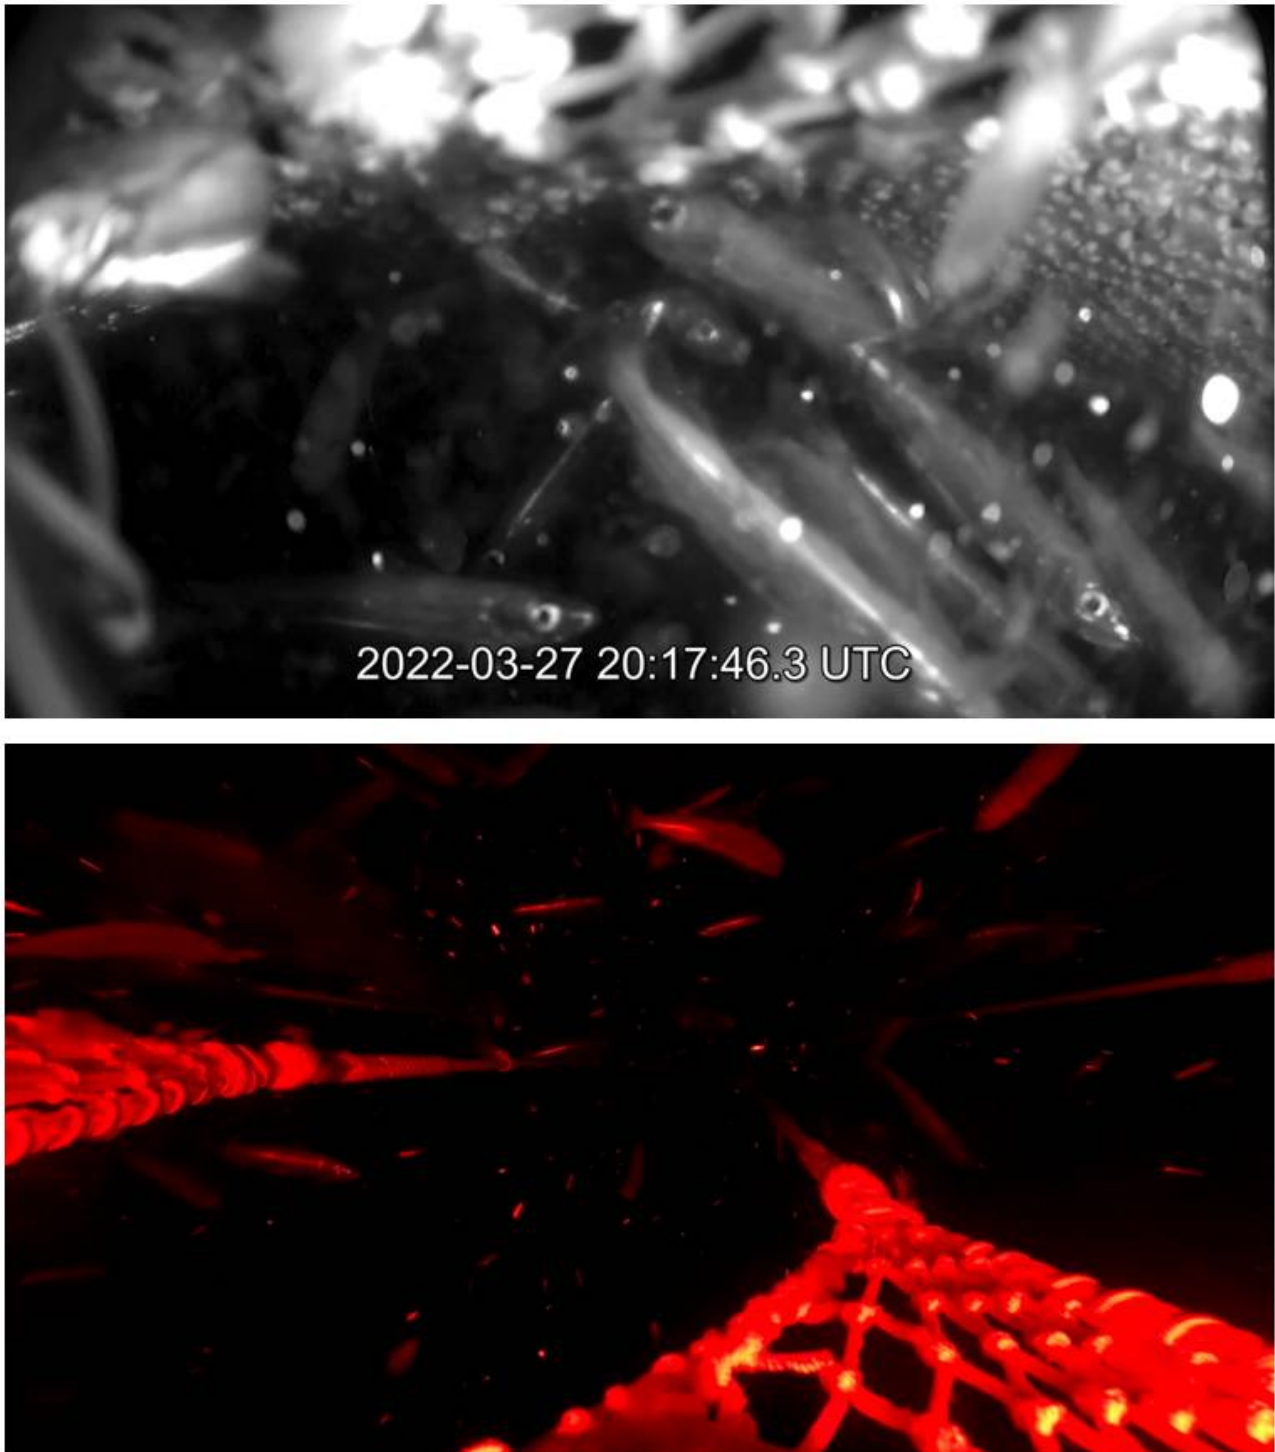
Figure 3.5 – Images from video taken during haul 03 at 20:17, 16 minutes before the start of haul-back at 20:33. Top: from position 5iB looking aft toward the fish-lock and cod-end, showing high densities of fish in the top of the FRS. Bottom: from position 2iF, looking forward over the escape opening, with medium densities of fish passing over the escaping open. Note – the escape rate was approximately 65 fish/minute [20:17 - 20:18].

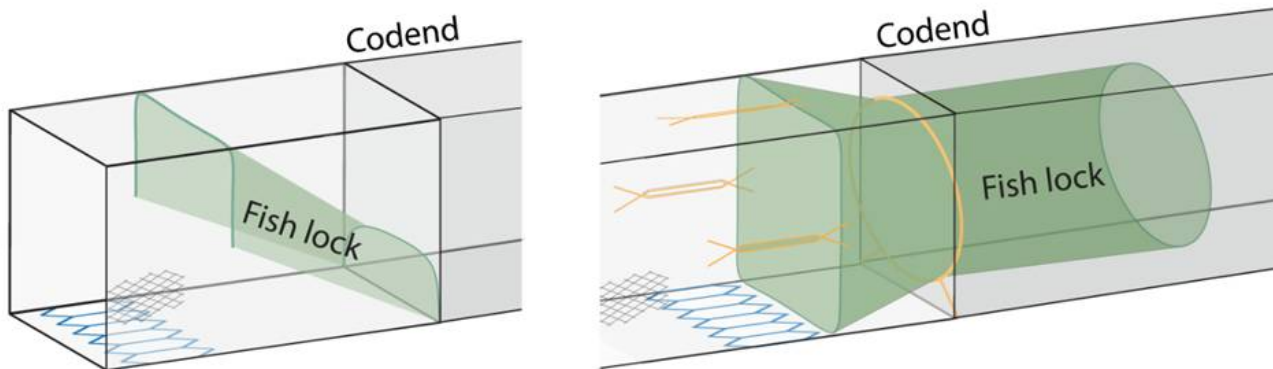
Figure 4.1 – Schematic diagrams of fish lock designs: Left – type 1, panel; Right – type 2, cylinder.

Two different “fish-lock” designs were tested during cruises 1 and 2. Type 1 was constructed of a netting panel 80 mm mesh size with 210/96 nylon (PA) twine, 74.5 meshes long (6 m). This was fixed to the top panel, approximately 0.3 m to the aft of the escape opening, and then fixed on a diagonal line down to about halfway down the side panels (and toward the cod-end). The operation of this design (type 1) was observed during cruise 1 and is described in Breen et al (2021). In summary, when water flow in the codend reduced during haulback, the lower/aft portion of the panel dropped to the bottom side of the codend preventing fish from escaping forward.

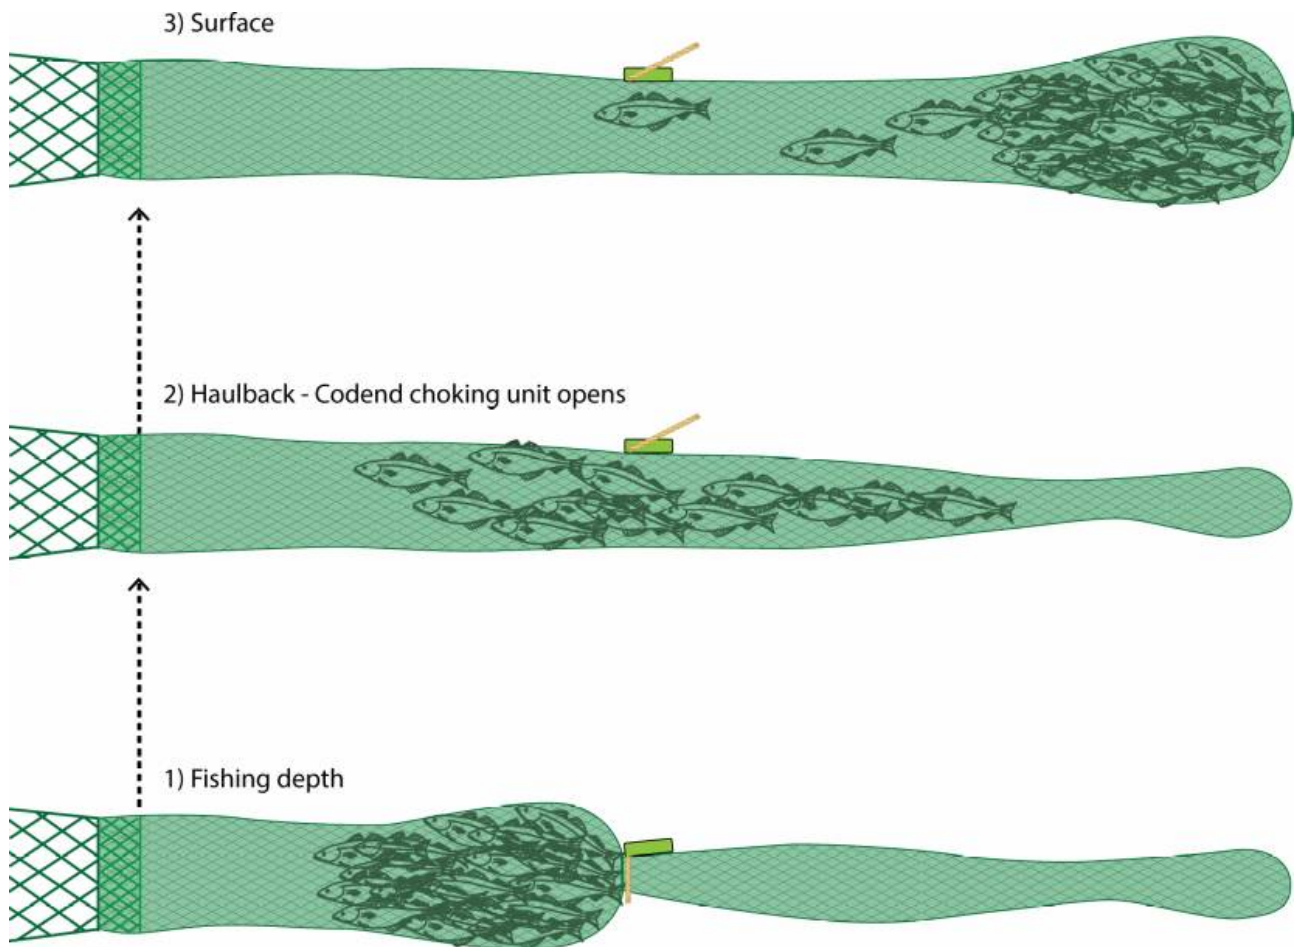
Figure 5.1 – Schematic diagram of the Cod-end choking unit in operation. 1: catch is retained in the cod-end ahead of the closed CCU; 2: the trigger depth is reached and the CCU opens; and 3: the retained catch dissipates into the residual component of the cod-end [Source: Ingolfsson et al, 2022].

The cod-end choking unit (CCU) is a prototype device (developed by FossTech AS) that can be placed at different locations along the length of the cod-end, to limit the effective volume of the cod-end and thus the volume of the retained catch (Ingolfsson et al, 2018; Breen et al, 2021). At a pre-determined depth (between 50 and 150m) during haul-back, the release mechanism opens allowing the restrictor-rope wrapped around the cod-end to release, which results in the retained catch moving (with the towing induced flow inside the trawl) into the residual cod-end (figure 5.1). If timed correctly, this transfer of the catch from the retaining cod-end into the residual cod-end should dissipate the catch over a larger volume within the cod-end. This will prevent the catch concentrating at the terminal end of the cod-end, which provides two key benefits: i) fish can freely decompress, evolving expanding gas from ruptured swim-bladders and body cavities during ascent; and ii) dissipate buoyant lift from the catch over a larger surface area in the ascending cod-end, thus increasing drag and reducing acceleration during ascent.

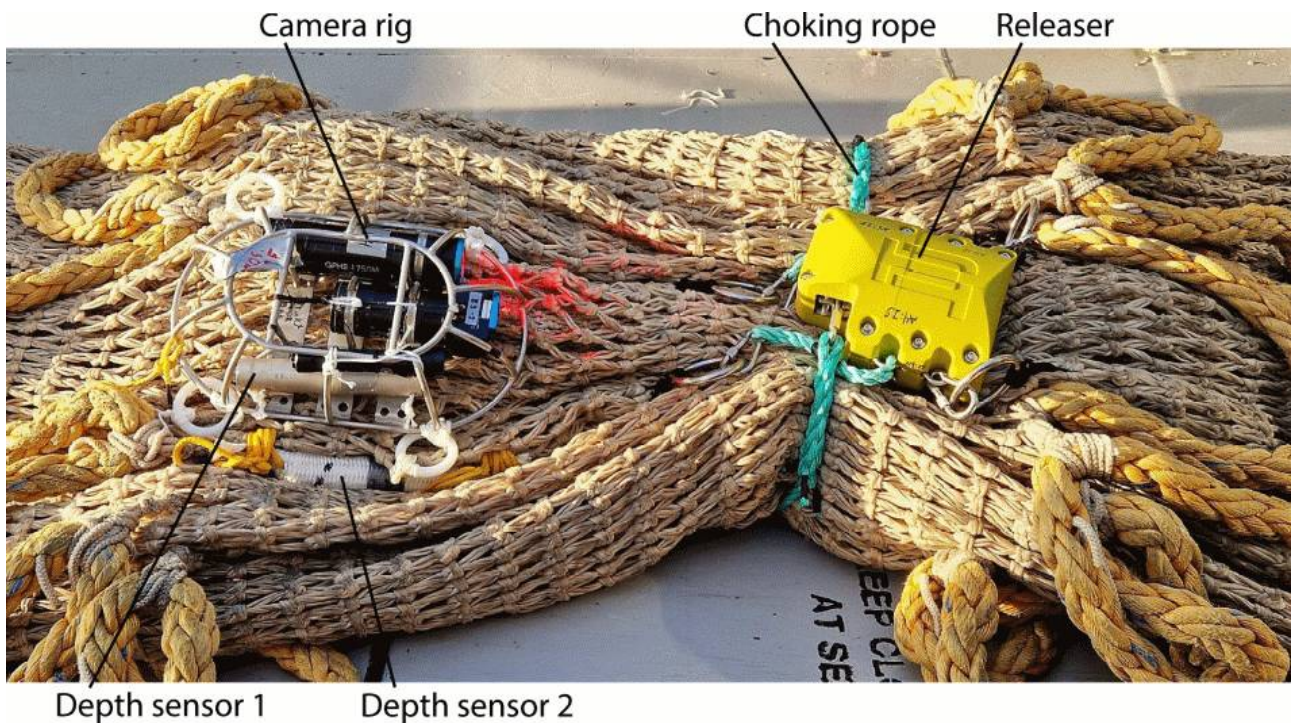
Figure 5.2: Haul A01, depth triggered cod-end choking unit (CCU) with a choking rope set at the 25m (~200t) position. Also shown is the camera and depth sensor assembly, in a protective steel frame, for monitoring the release depth of the CCU [Source: Ingolfsson et al, 2022].

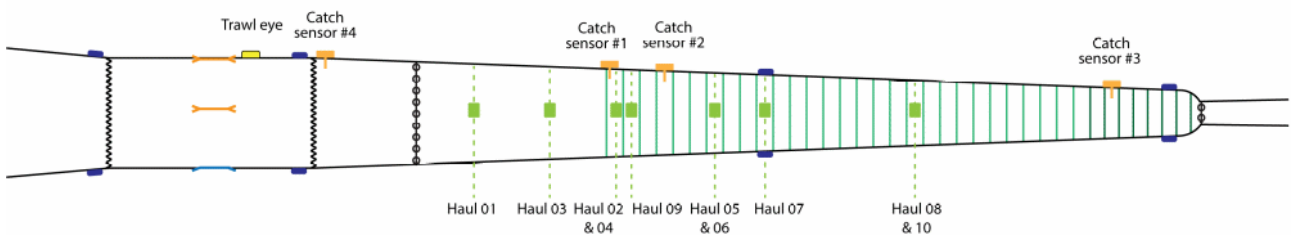
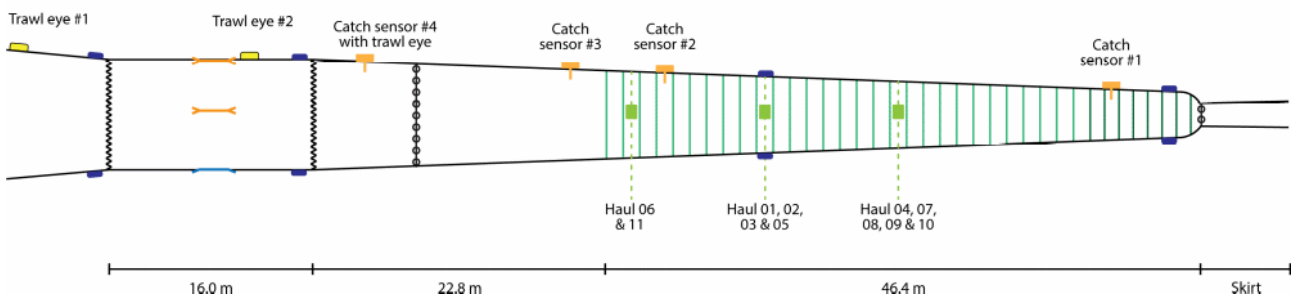
Figure 5.3 - positions on the cod-end of the Cod-end choking unit (CCU) and other instruments for cruise 1 (top) and cruise 2 (bottom). Releaser positions for each haul in both cruises are shown in green (see also table 5.2). Also shown are the relative positions of the “Trawl-Eye” echo-sounders (yellow), Catch Sensor units (orange) and depth-sensors (blue). [Source: Ingolfsson et al, 2022].

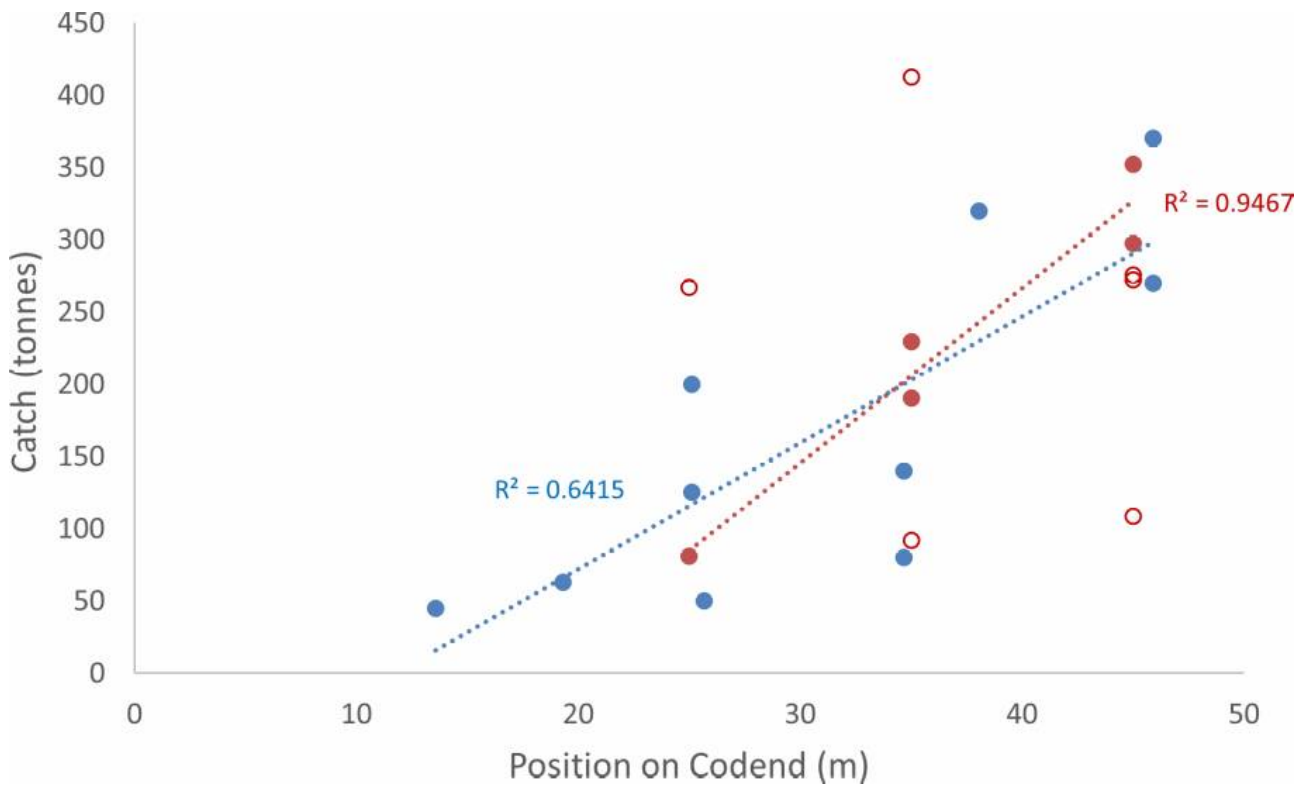
Figure 5.4 – The relationship between targeted catch size (tonnes) and the position (metres) of the CCU relative to the forward edge of the cod-end. Multiple linear regression analysis determined that catch size increased significantly the further aft the catch limitation releaser was positioned on the cod-end ($t = 5.41$; $p < 0.001$), while there was no significant difference between the relationships for either cruise ($t = -0.40$; $p = 0.699$). Blue dots show results from cruise 1 and red dots cruise 2. Open circles show hauls where problems with the releasers were experienced and are not included in the regression analysis. [Source: Ingolfsson et al, 2022].

There was a significant relationship between CCU position on the cod-end and the actual catch (in tonnes) ($t = 5.41$; $p < 0.001$) (figure 5.4). Furthermore, there was no significant difference in the relationship for either cruise ($t = -0.40$; $p = 0.6990$). The relationship for the valid hauls from cruise 2 was far more consistent than for the cruise 1 data (R^2 : 0.9467 and 0.6415, respectively), likely because known problems with catch control were deliberately removed from the dataset. Indeed, the spread of the invalid hauls (open circles in figure 5.4) are at least as variable as the cruise 1 data. This suggests that the higher variation in cruise 1 may be the result of catch leakage and prematurely terminated hauls, which were not appreciated at the time.

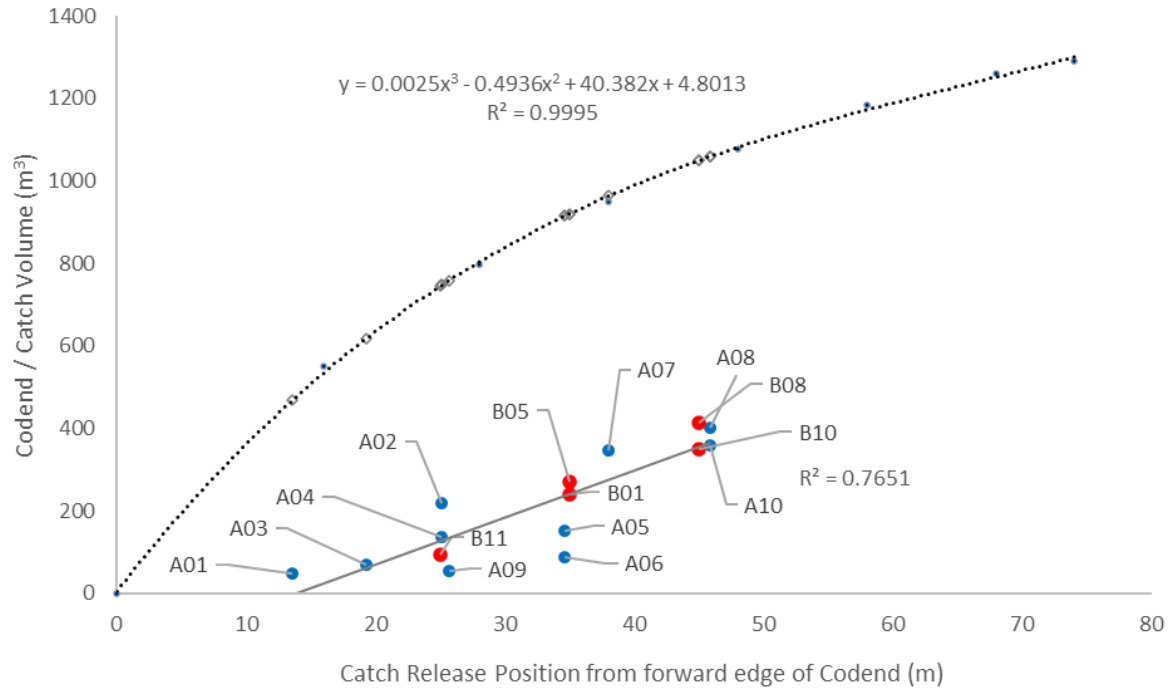
Figure 5.5 - The relationship between the position of the Catch Limit Releaser (CCU) and the resultant cod-end and catch volumes. Theoretical (third order polynomial; R^2 0.9995) cod-end volume estimates are shown in black, and theoretical volume calculated specifically for each haul as open grey diamonds. The resultant catch volume (m³) for each haul is shown for cruise 1 (blue) and cruise 2 (red), with a combine fitted linear relationship (black solid line; R^2 0.7651).

Finally, as anticipated, the resultant catch volume (and weight, see above), generally increased the further aft the CCU was positioned on the cod-end, as the theoretical volume of the receiving cod-end increased (figure 5.5). However, the resultant valid catch volumes only represented a small proportion of the corresponding theoretical cod-end volumes (range 0.072 – 0.394)(table 5.2). In addition, larger catch volumes generally occupied a higher proportion of the corresponding theoretical cod-end volume (figure 5.6), suggesting catch density increased with increasing catch size. One possible explanation for this observation is that larger cod-end volumes may allow higher densities of catch to accumulate before “excess catch” begins escaping from the openings in the FRS. This could be related to the increased time required to collect larger catches, which may increase the probability of fish becoming exhausted and falling back to the rear of the cod-end, as time progresses. This process could be verified by appropriate positioning of cameras and/or Trawl-Eye units along the cod-end. The increased density of catch may also have implications for the swim-bladder gases retained in the catch volume. Higher packing densities may make the fishes’ swim-bladders less likely to rupture during ascent, as well as increasing the likelihood of released gas retention within the interstitial spaces in the catch. In combination with the increased potential gas volume within large catches, this could increase the likelihood of excessively rapid cod-end ascent rates during haul-back.

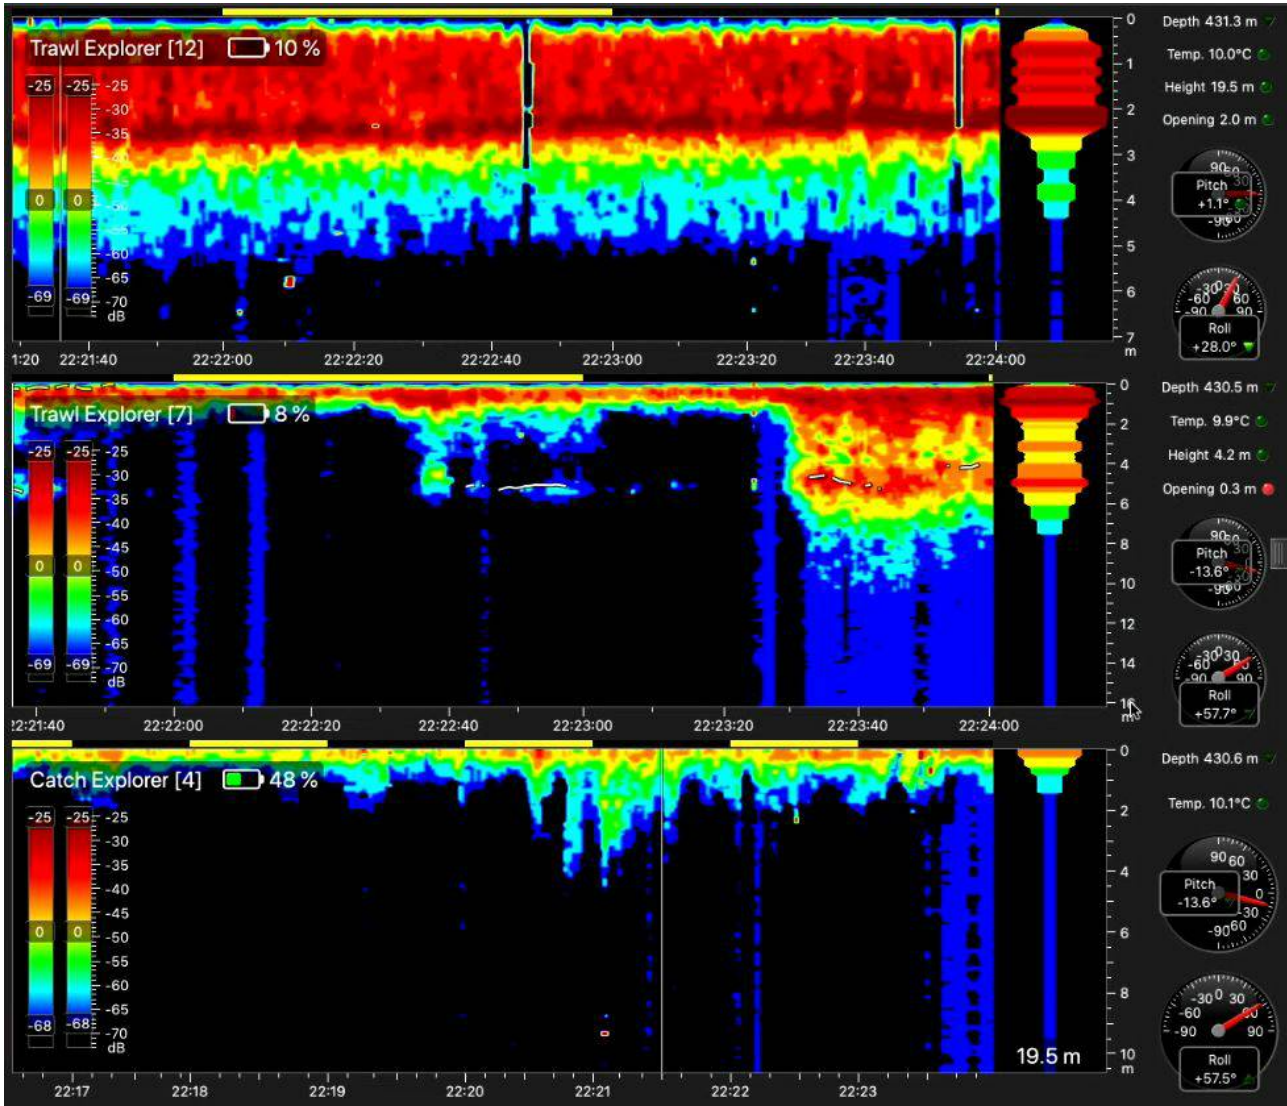
Figure 6.1 – Cod-end echo-sounder (CE_ES) echogram output from haul B05, just before haul-back began. Top: from forward of the FRS at CE-ES #1; Centre: from above the FRS at CE-ES #2; and Bottom: from behind the FRS at CS #4. CE-ES #1 shows high density accumulations of fish ahead of the FRS, while both CE-ES #2 CS #4 have periods where the densities are so high that the signal becomes occluded. These signals were confirmed by video camera (see figure 6.2).

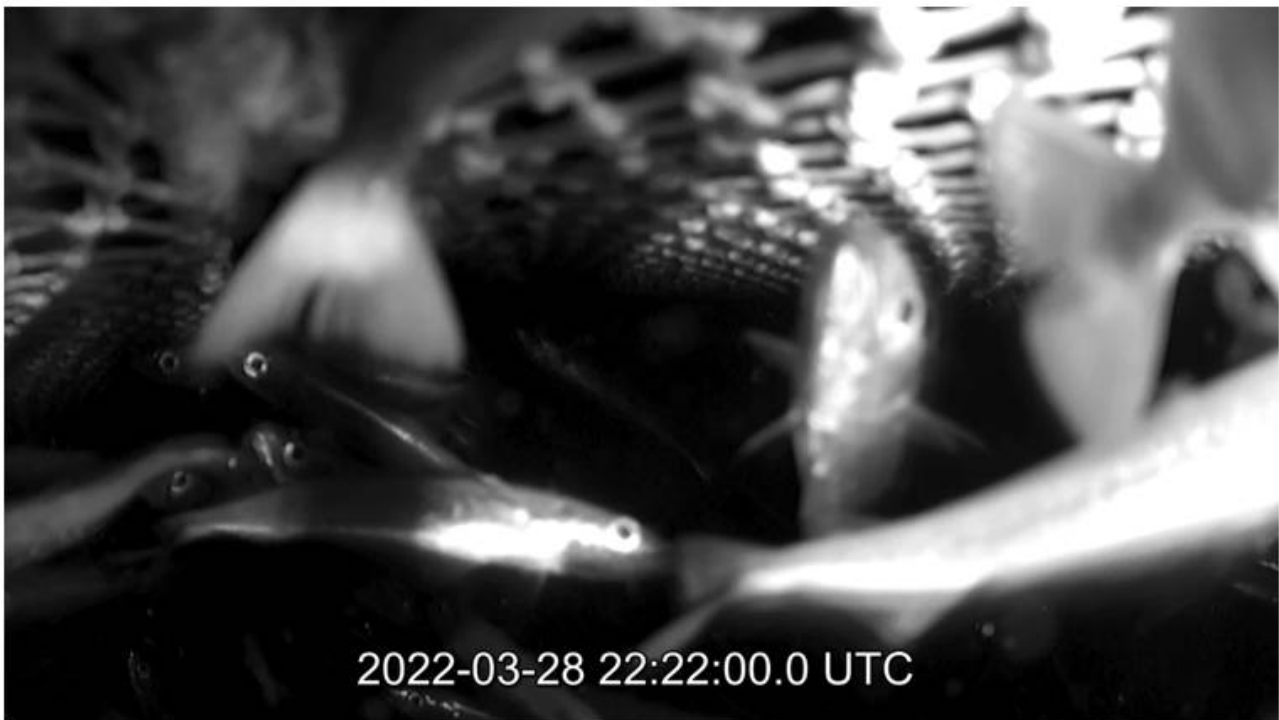
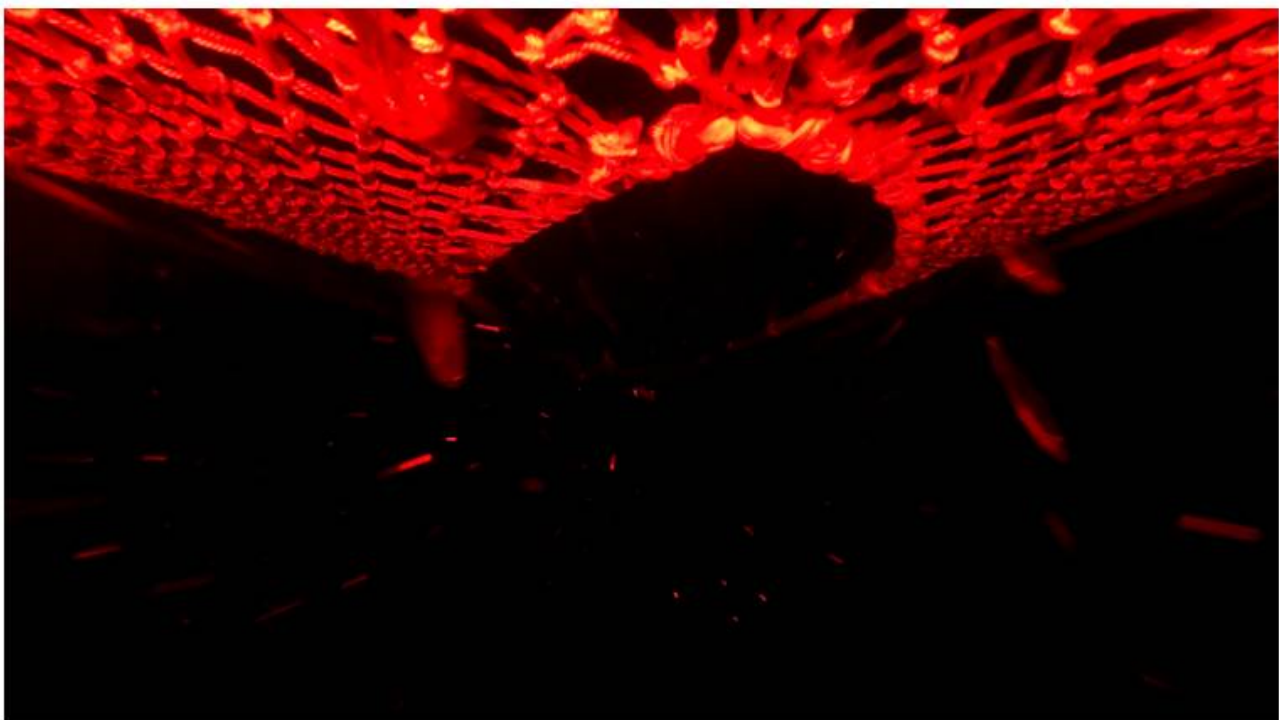
Figure 6.2 – Images from video taken at 22:22 during haul B05, just before the start of haul-back at 22:24. Top: from position 5B look aft toward the fish-lock and cod-end, showing high densities of fish in the top of the FRS. Bottom: from position 4F, looking forward below the escape opening, with three fish escaping. Note – the escape rate at this time was approximately 42 fish/minute [22:22-22:23] and 39 fish/minute [22:24-22:25].

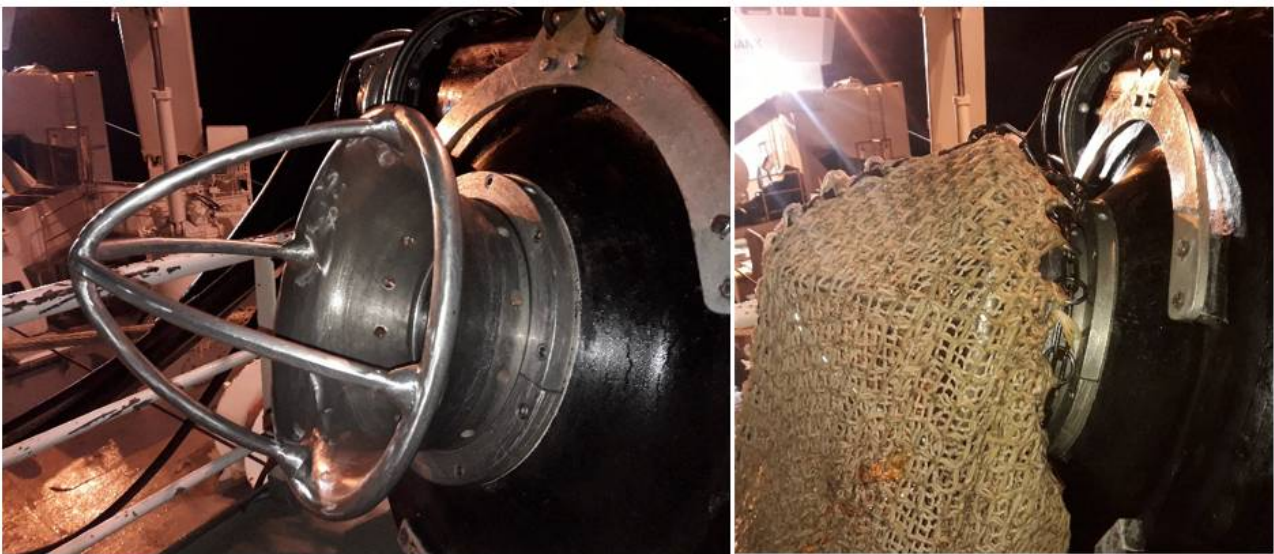
Figure 7.1 - Left: the pump-head funnel; and Right: pump with pump skirt connected [Source: J. Saltskår].

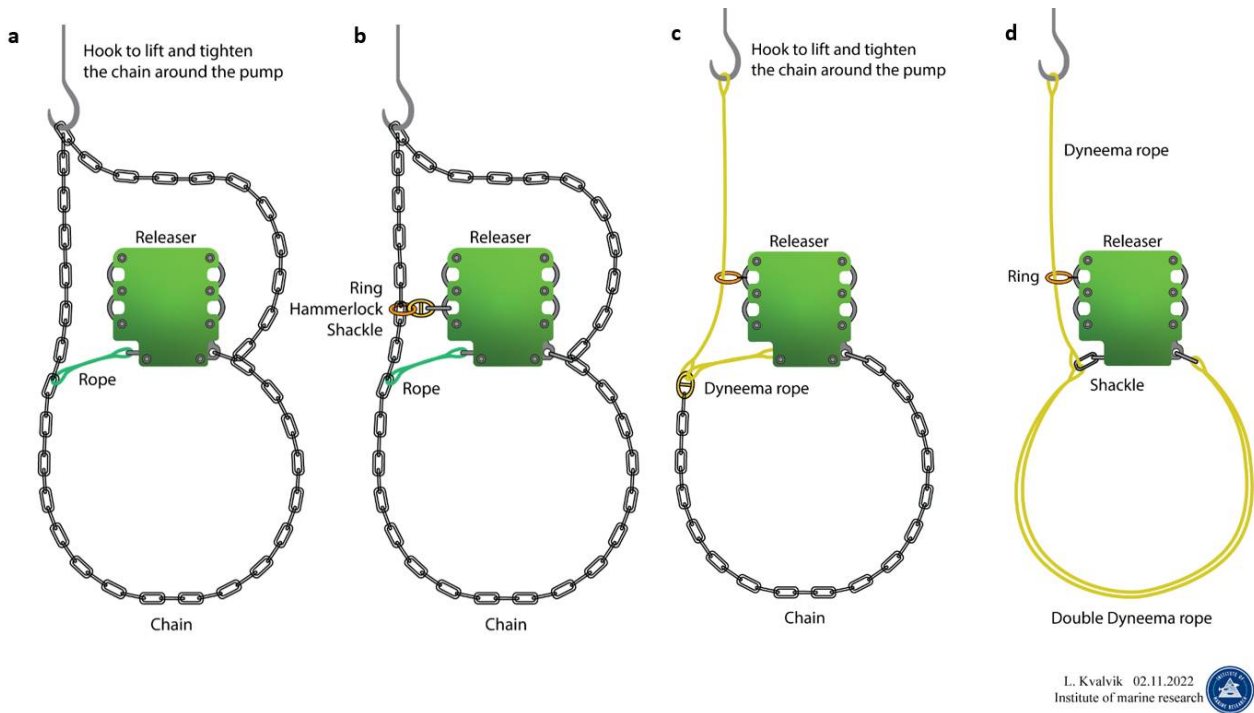
Figure 7.2: Schematic drawings of releaser with various rigs for securing the cod-end skirt to the pump-head. a: rig 1 used in tests A1, A2 & B1; b: rig 1a used in test B2; c: rig 2 used in tests C1 & C2; and d: rig 3 used in test C3.

Seven separate tests were conducted, using two different releasers (#1: A4:29; and #2: 9E:27) (table 7.1), with four different configurations of rigging securing the cod-end skirt to the pump-head (figure 7.2). During each test, the releaser and securing line/rig assembly was attached to the pump head and then lowered by crane into the water to a depth exceeding the target releaser trigger depth of 30m. Each test was observed underwater using a camera (Tests A1, A2 & B1: GoPro 7; and all other tests: GoPro 5) paired with a Star-Oddi Starmon TD sensor (depth & temperature; D-0145), to determine when and at what depth the release occurred. A Marport depth sensor was also attached to the pump-head to give real-time depth readings during all tests (except test A1).

Test B1: this was the first trial with the cod-end skirt attached to the pump using the releaser and securing line/rig (figure 7.2a, rig 1; & 7.3b). The assembly was deployed to a maximum depth of 46.0m and again released, but the time and depth of release were unknown because the GoPro 7 camera fitted to the pump-head failed to record.

Test C3: In this test, the securing chain was completely replaced with a doubled length of Dynaema twine, with a shackle at one end forming a hard-eye for inserting into the releaser jaw (figure 7.2d). It was conducted at the end of a test-haul 02. After the test-haul, the cod-skirt was attached to the pump-head, as would be done during normal fishing operations (see above). The pump-head was deployed to a maximum depth of 41.9m but unfortunately the releaser failed to open (table 7.1). When the pump-releaser assembly was recovered and examined, it was observed that the releaser jaw had not fully opened, with the releaser arm partially up. Detailed mechanical examination of the releaser unit provided no explanation for this failure, and again it was presumed there was insufficient force to open the releaser jaw fully.

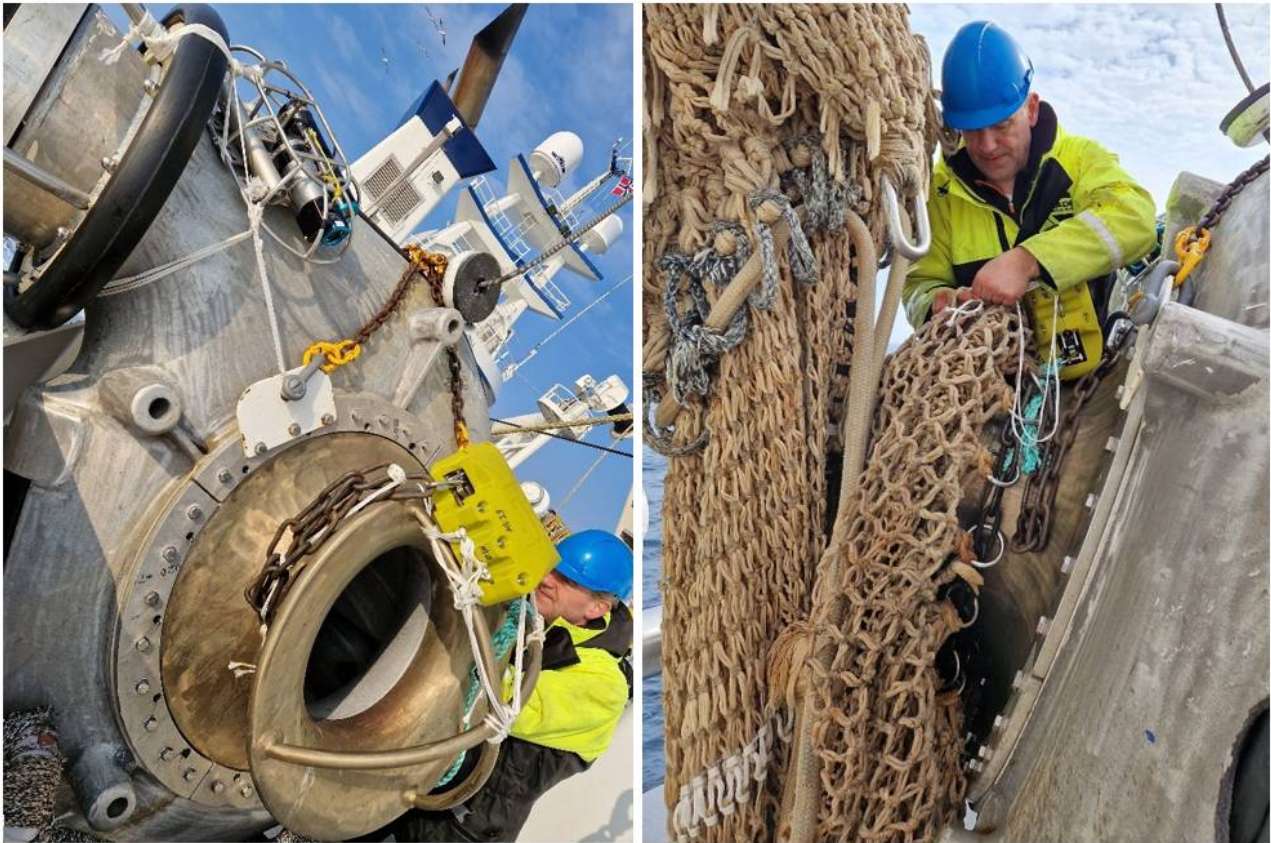
Figure 7.3 – Left: releaser and securing chain (Rig A) attached to pump-head, without the cod-end skirt attached. Camera and depth-sensor array is in a protective steel frame at the top of the image. Right: releaser and securing chain (Rig A) with the cod-end skirt fitted to the pump-head, showing the release jaw side of the releaser.

Test A1: 24th March 2022. The releaser and securing chain were fitted to the pump, without the cod-end skirt attached (figures 7.2 & 7.3a). The assembly was deployed to a maximum depth of 41.1m but failed to release. It was suspected that there was insufficient force on the locking jaw of the releaser to open it.

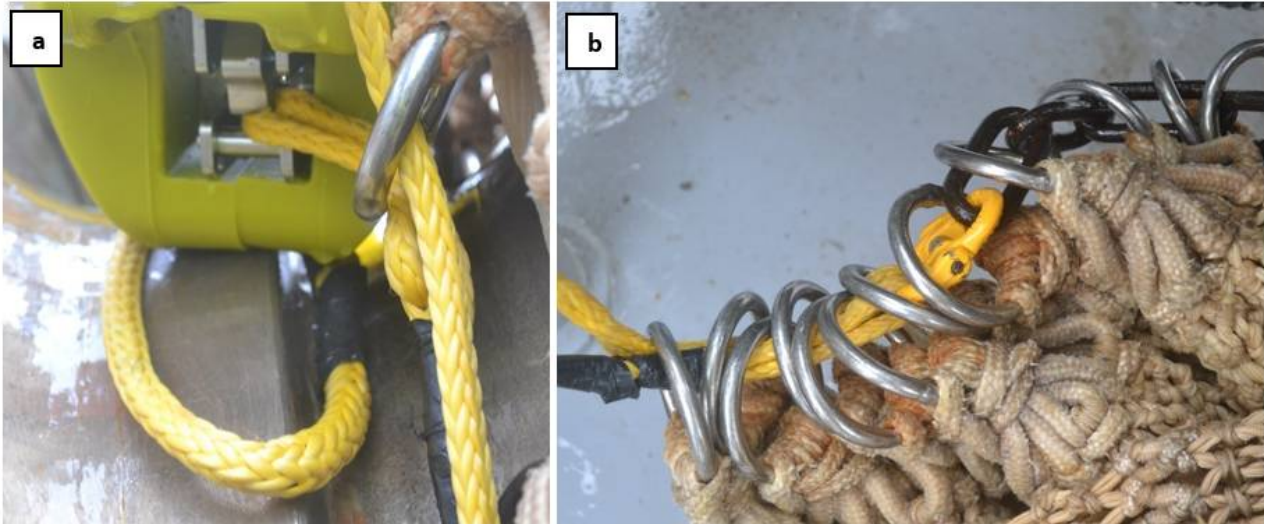
Figure 7.5 – Observations after test C-2 (rig 2); a: the soft eye was only partially released from the releaser jaw; and b: the hammerlock linking the Dynaema twine to the securing chain was jammed in the cod-end skirt rings.

Test C2: this was a repeat trial with the same rig as test C1 (rig 2). The pump-head was deployed to a maximum depth of 42.3m but unfortunately the releaser failed to open (table 7.1). When the pump-releaser assembly was recovered and examined, it was observed that the soft eye was partially released from the releaser jaw (figure 7.5a). Moreover, the hammerlock linking the Dynaema twine to the securing chain was jammed in one of the rings around the cod-end skirt (figure 7.5b). In combination, these observations suggest that, because the securing line was not free to pass through the rings, there was insufficient force to fully open the releaser jaw when it was triggered to release. It was also suspected that the soft-eye in the Dynaema may have contributed to this lack of force by being to slip partially out of the releaser jaw.

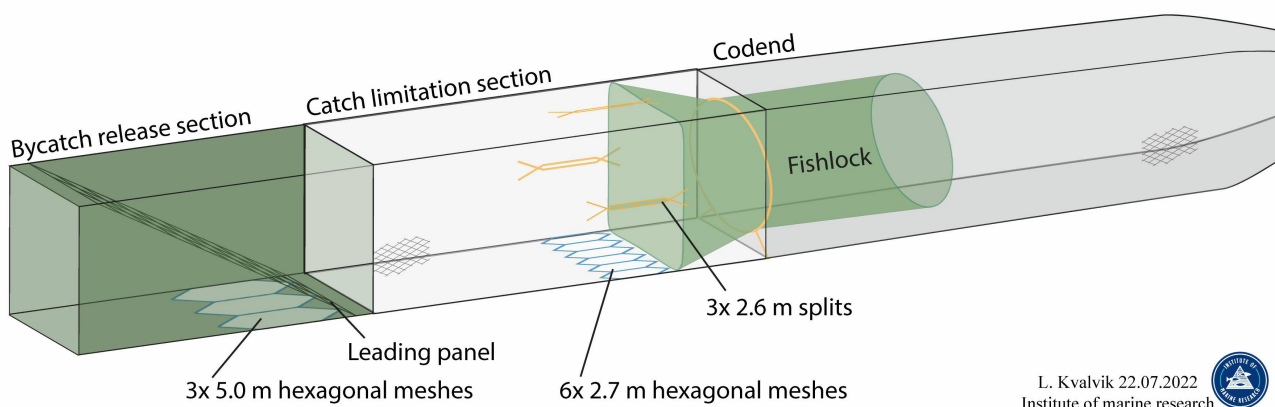
Figure 8.1 - Bycatch Release Section (BRS) was fitted immediately forward of the Fish Release Section (FRS) of the Catch Limitation System (CLS).

The Bycatch Release Section (BRS) was fitted immediately forward of the Fish Release Section (FRS) of the Catch Limitation System (figure 8.1). It consisted of a 12.0m long four-panel cylindrical section of 80mm diamond mesh netting, in the bottom panel of which were cut three 5.0m long hexagonal escape openings (figure 8.2a). Inside the FRS was an 11.2 long diagonal leading panel of 600mm (300 by 300mm) square mesh netting, set at an angle of approximately 16° (figure 8.2a). The BRS was fitted to the trawl during four hauls (table 2.1). Test hauls 1 and 2 were used to make video and trawl sonar observations of the FRS and BRS sections, to ensure they were fitted correctly. Haul 01 was the first behavioural observations with a live catch. Based on these observations modifications were made to the BRS, by cutting away a 1.2 by 2.7 m opening at the top end of the leading panel (figure 8.2b). This version was tested in haul 07.
