CATCH CONTROL IN THE BLUE WHITING PELAGIC TRAWL FISHERY

Research Cruise Report [2022825]: FV "Vikingbank"

TOKTRAPPORT
No.1 2023

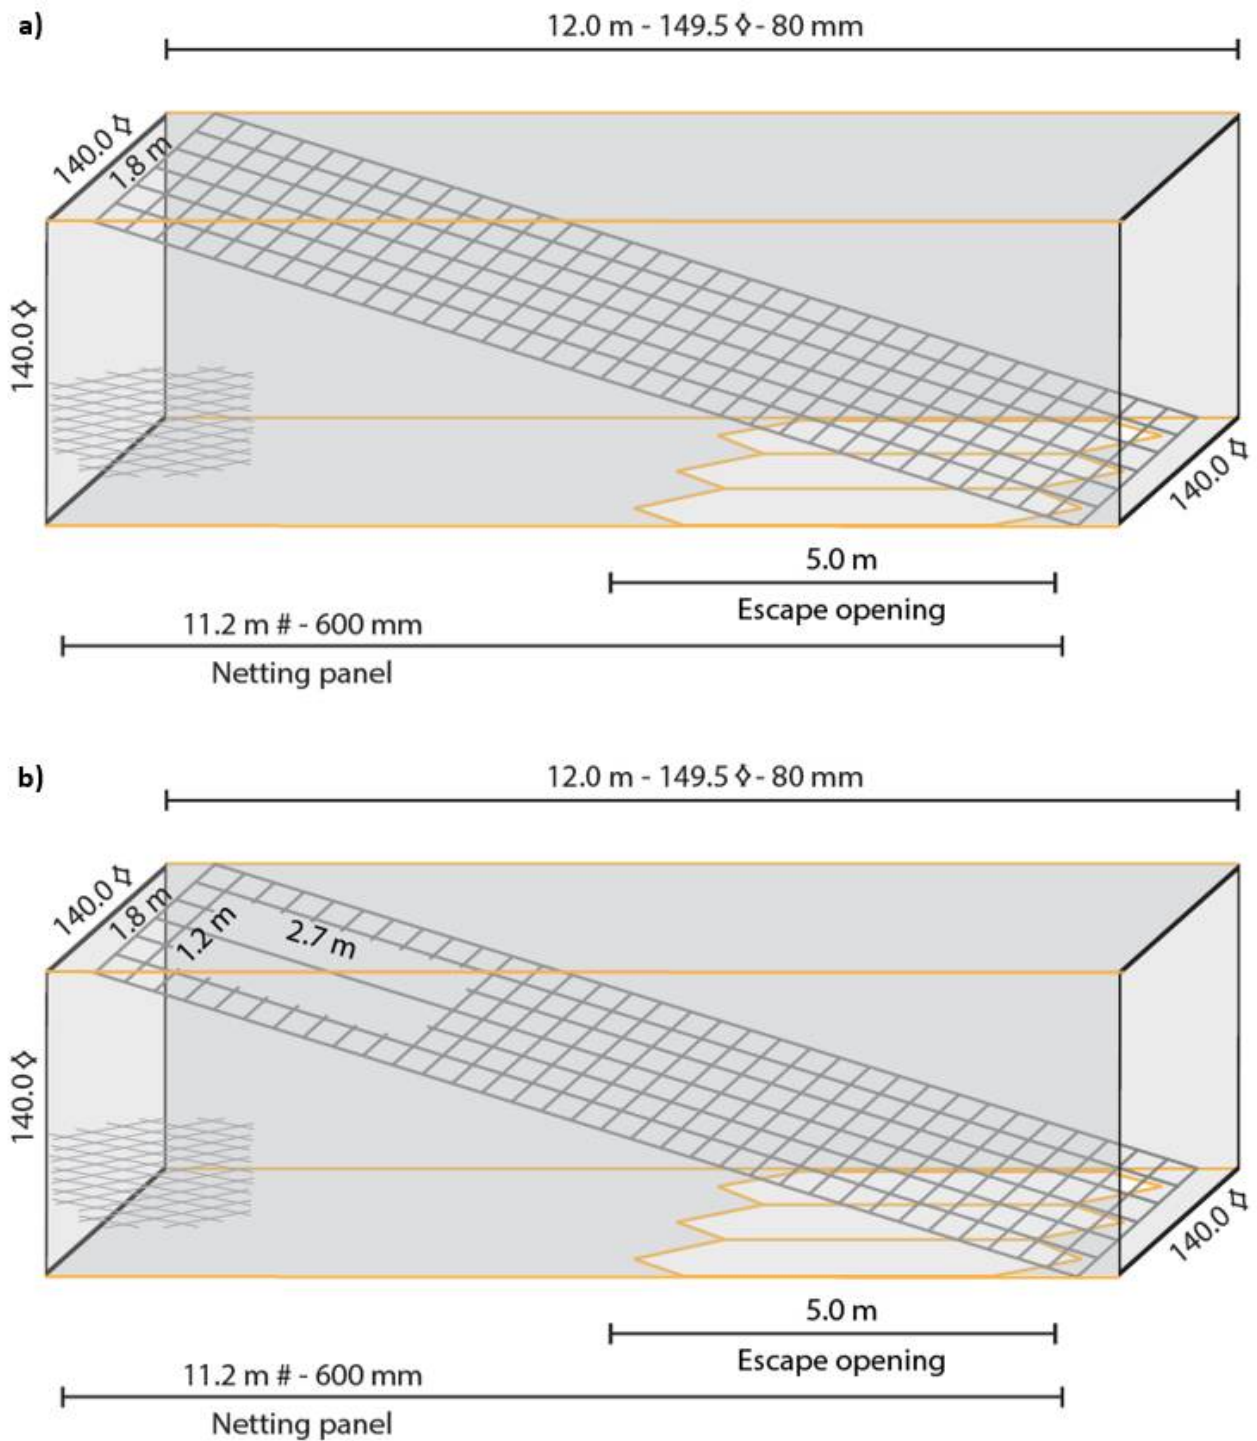
Figure 8.2 – Schematic drawings (not to scale) of the Bycatch Release Section (BRS): a) version 1 used in Test Hauls T1 & T2 and Haul 01; and b) version 2, with a hole cut in the leading panel, used in Haul 07.

The Bycatch Release Section (BRS) was fitted immediately forward of the Fish Release Section (FRS) of the Catch Limitation System (figure 8.1). It consisted of a 12.0m long four-panel cylindrical section of 80mm diamond mesh netting, in the bottom panel of which were cut three 5.0m long hexagonal escape openings (figure 8.2a). Inside the FRS was an 11.2 long diagonal leading panel of 600mm (300 by 300mm) square mesh netting, set at an angle of approximately 16° (figure 8.2a). The BRS was fitted to the trawl during four hauls (table 2.1). Test hauls 1 and 2 were used to make video and trawl sonar observations of the FRS and BRS sections, to ensure they were fitted correctly. Haul 01 was the first behavioural observations with a live catch. Based on these observations modifications were made to the BRS, by cutting away a 1.2 by 2.7 m opening at the top end of the leading panel (figure 8.2b). This version was tested in haul 07.

Haul 01 demonstrated that a substantial proportion of blue whiting encountering the leading panel in the BRS was exiting via the escape openings (figures 8.4 & 8.5). Although the mesh openings in the leading panel were relatively large (300 by 300mm square), at the shallow angle (~16o) they were presented to the fish approaching the leading panel they would have had a projected vertical opening of only ~63mm. Based on this and the knowledge that blue whiting entering the cod-end tend to accumulate higher up, while the porbeagle observed in cruise 1 swam along the bottom of the cod-end (Breen et al, 2021), it was decided to cut a hole in the upper part of leading panel in an attempt to reduce the excessive loss of blue whiting from the BRS (figure 8.2b).

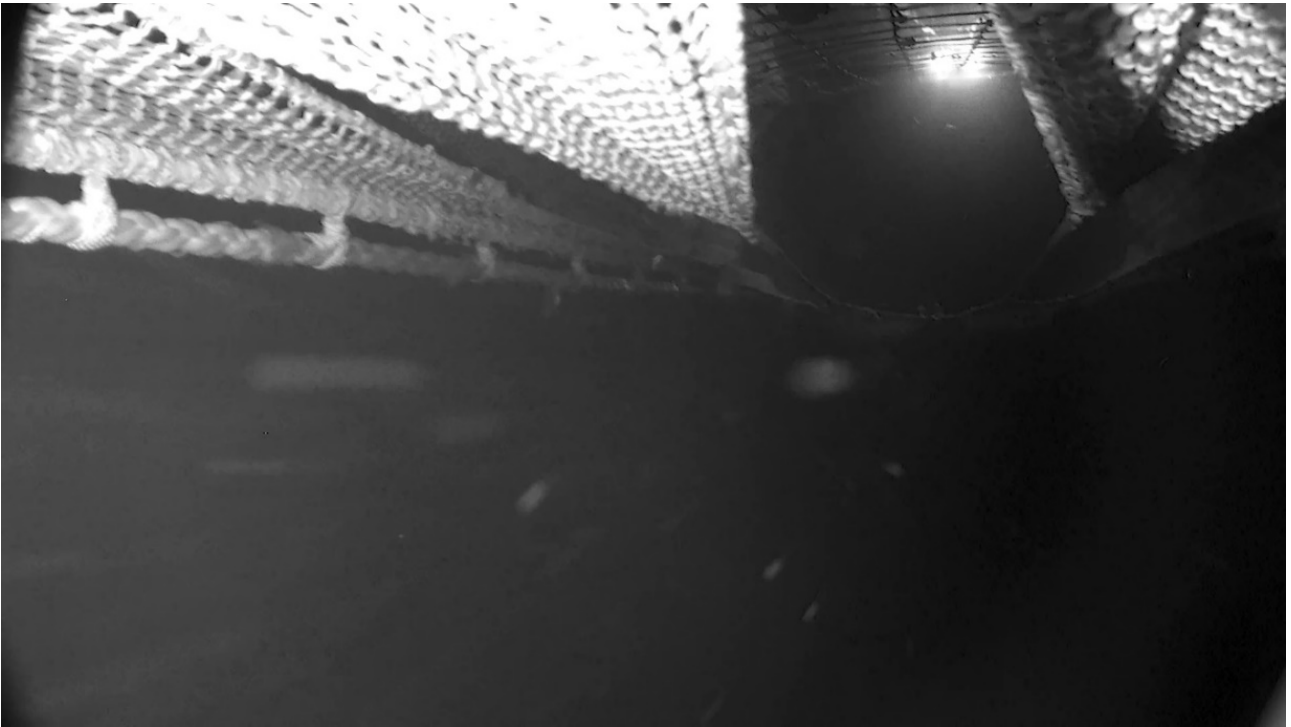
Figure 8.3 – view from camera position 6oF, showing the leading panel visible through the escape openings of the BRS.

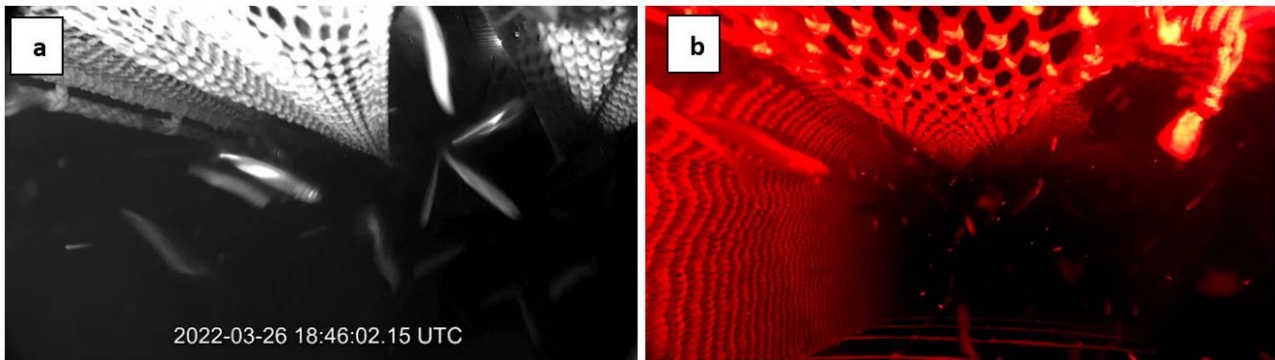
Figure 8.4 – images from video early in haul 01 [18:46:02]: a) position 6oF, below the BRS escape opening, shows a substantial number of blue whiting escaping; while b) position 9iB, inside the BRS aft of the leading panel, shows few blue whiting passing through panel. For comparison, at this same time, escapes from the bottom opening in the FRS were only 7 fish per minute, but it was difficult to differentiate between fish exiting via the BRS and FRS, so this estimate could be less (position 2oF, not shown).

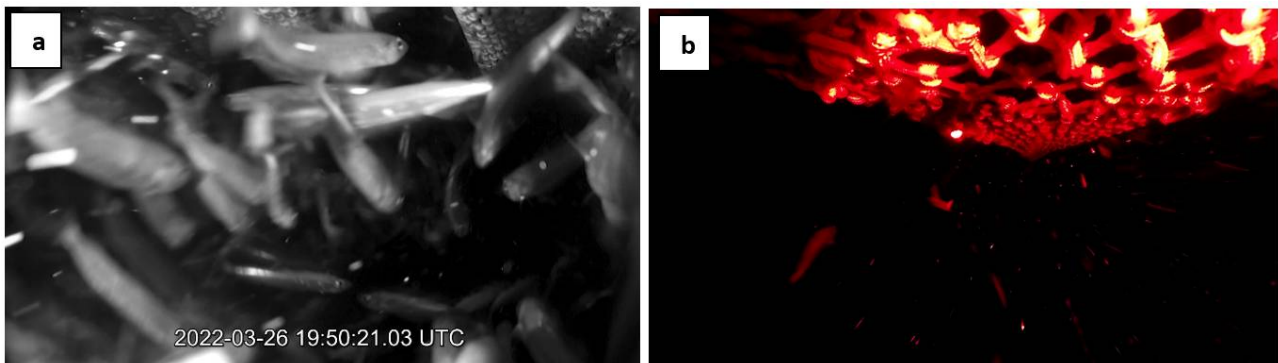
Figure 8.5 – images from video later in haul 01 at higher catch densities [19:50:21]: a) position 6oF, below the BRS escape opening, shows a very substantial number of blue whiting escaping; while b) position 2oF, outside the bottom opening in the FRS, shows fewer blue whiting escapes. For comparison, the escape rate from the bottom opening in the FRS (position 2oF) at this time was approximately 30 fish per minute, but it was difficult to differentiate between fish exiting via the BRS and FRS, so this estimate could be less. Unfortunately, there was no video available inside the BRS at this time, because the camera at position 9iB stop recording at 18:46:10.

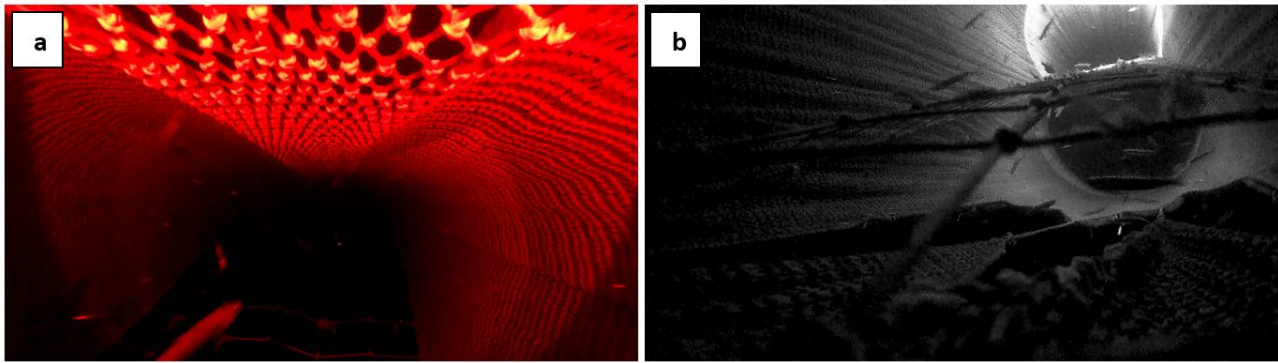
Figure 8.6 - images from video inside the BRS early in haul 07 [03:10:47]: a) position 7iF, looking forward towards hole in leading panel; b) position 6iF (DarkVision camera), looking forward from behind the leading panel, with escape holes in bottom panel visible in the foreground. DarkVision camera operating without its own light during this period.

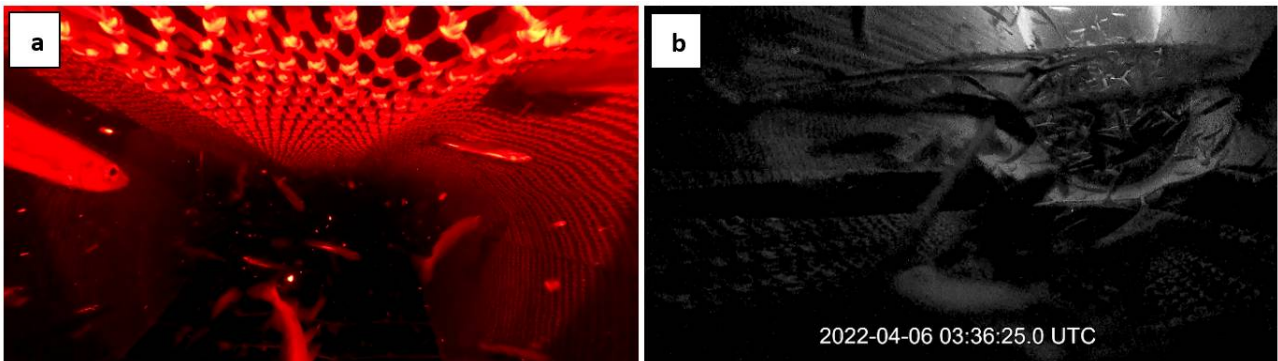
Figure 8.7 - images from video inside the BRS early in haul 07 [03:36:25]: a) position 7iF, hole in leading panel allowing fish through in upper part of BRS; b) position 6iF (DarkVision camera), moderate fish density in front of panel with some fish passing through the lower panel, while a substantial proportion is deflected down and out of the escape openings. DarkVision camera operating without its own light during this period.

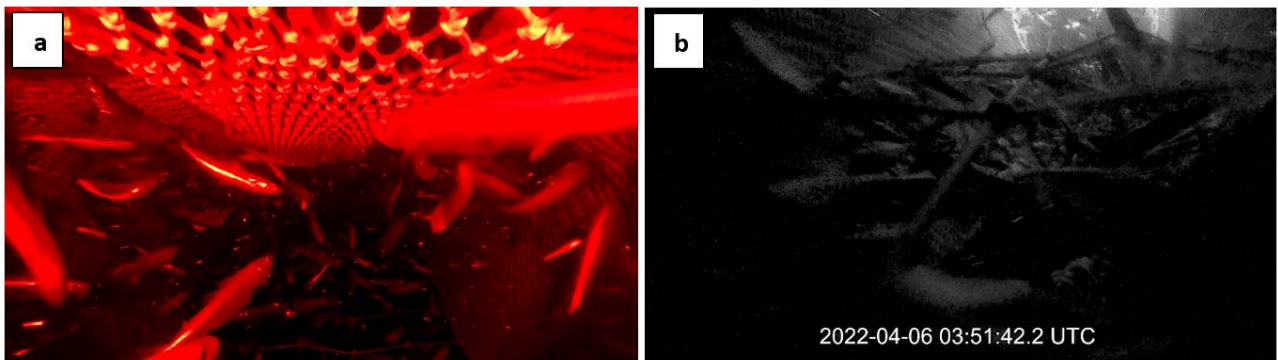
Figure 8.8 - images from video inside the BRS early in haul 07 [03:51:42]: a) position 7iF, hole in leading panel allowing fish through in upper BRS; b) position 6iF, in contrast at higher fish densities the deflection of fish down the leading panel causes a blockage. DarkVision camera operating without its own light during this period.

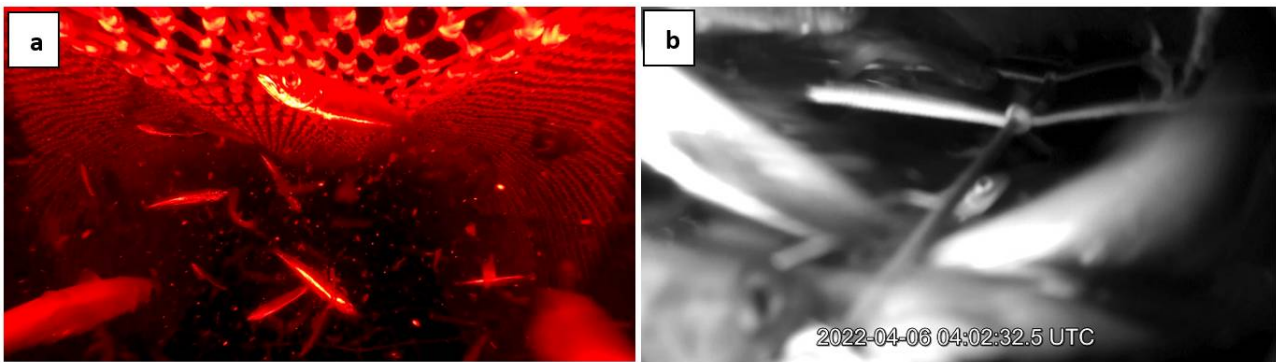
Figure 8.9 - images from video inside the BRS early in haul 07 [04:02:32]: a) position 7iF, hole in leading panel allowing fish through in upper BRS; b) position 6iF, in contrast at higher fish densities the deflection of fish down the leading panel causes a blockage. DarkVision camera operating without its own light during this period.

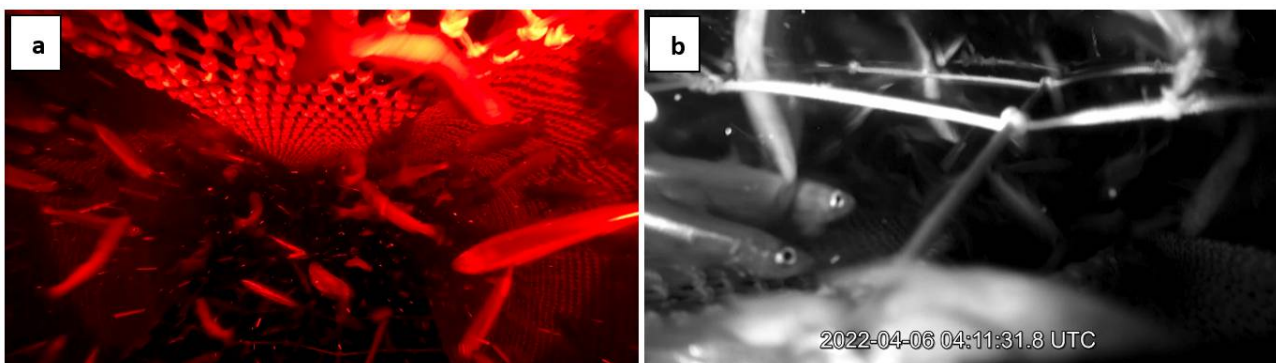
Figure 8.10 - images from video inside the BRS early in haul 07 [04:11:31]: a) position 7iF, hole in leading panel allowing fish through in upper BRS; b) position 6iF, moderately high fish density in front of panel with some fish passing through and frequently contacting the panel, while a substantial proportion is deflected down and out of the escape openings.

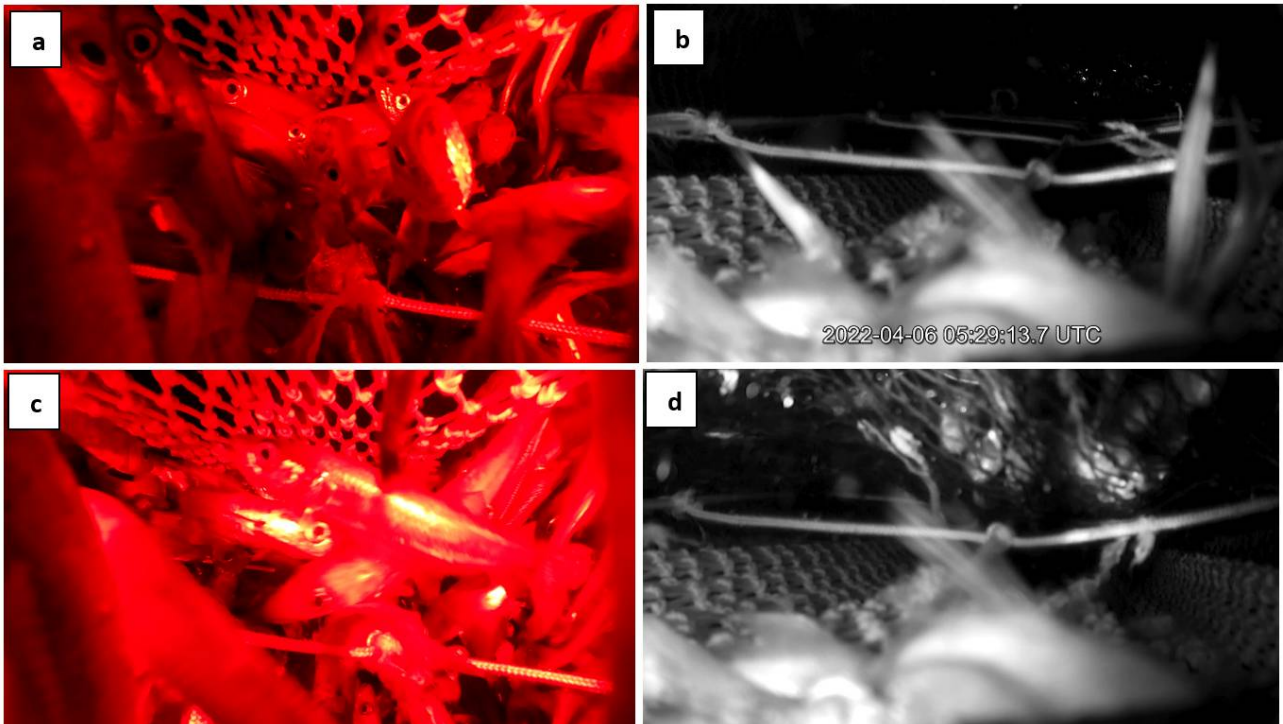
Figure 8.11 - images from video inside the BRS during hauling haul 07 [05:29:13]: a) position 7iF [05:29:13], fish accumulating at top of the leading panel; b) position 6iF [05:29:13], accumulation of fish at the top of the leading panel visible as speckles in the background; c) position 7iF [05:29:21], fish accumulating at top of the leading panel; and d) position 6iF [05:29:21], mass of fish trapped in netting behind the leading panel.

At the end of haul 07, during hauling, there was an unexplained crowding event observed by camera positions 6iF and 7iF (figure 8.11). At 05:29, there was an accumulation of fish ahead of the upper part of the leading panel in the BRS (figure 8.11a & b). At this time there was a reduced water flow in the trawl, and it is assumed that these fish had been ahead of BRS at the end of the fishing tow. Within less than 30 seconds the view at camera position 6iF was obstructed by a mass of fish trapped inside a netting fold. It is unclear what part of the trawl is forming this netting fold, but it is thought unlikely to be the fish lock in the CLS (which did invert during this haul; see section 4) because this was 16m aft of this position, and the fish-lock netting panel has a maximum length of 11.64m. This type of event was not observed in haul 01.

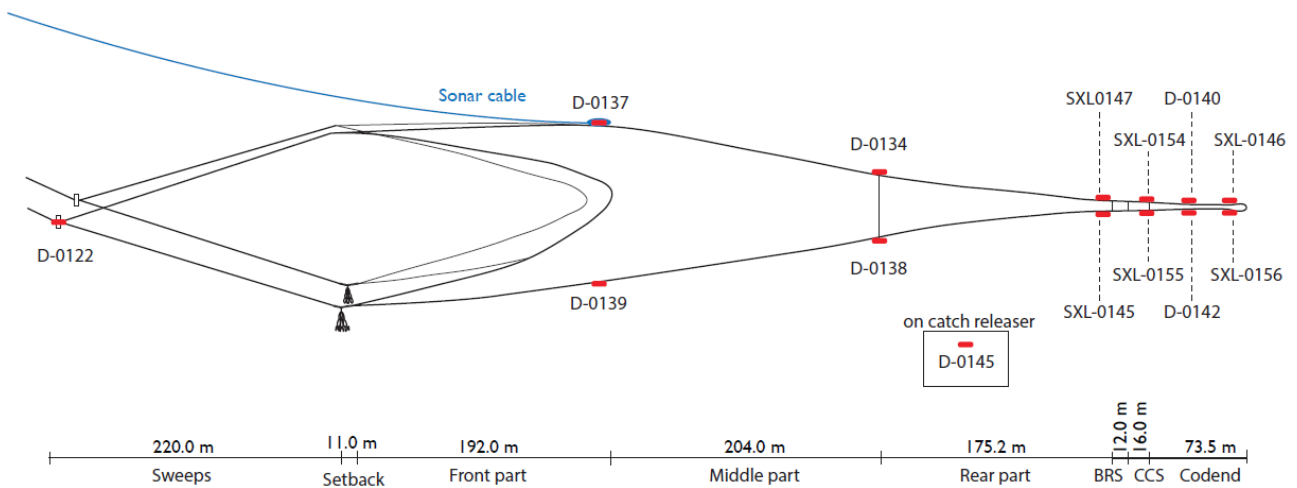
Figure 9.1 - Positions and Identity Code for depth sensors on the trawl. Detailed positions for the cod-end depth sensors are detailed in table 9.1. [Source: Liz Kvalvik].

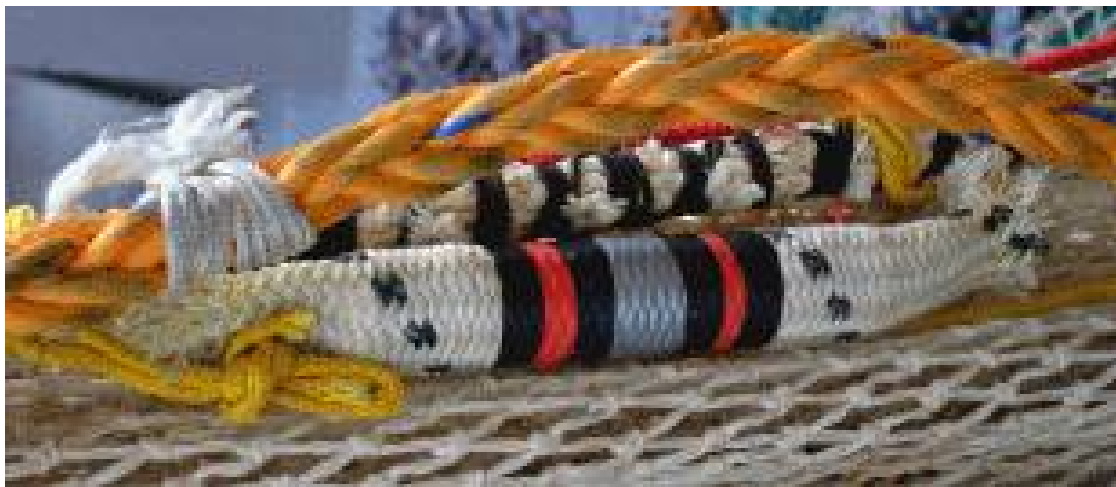
Figure 9.2 – a depth sensor (SXL-0154) in its protective housing and sheath fixed to the top of the FRS.

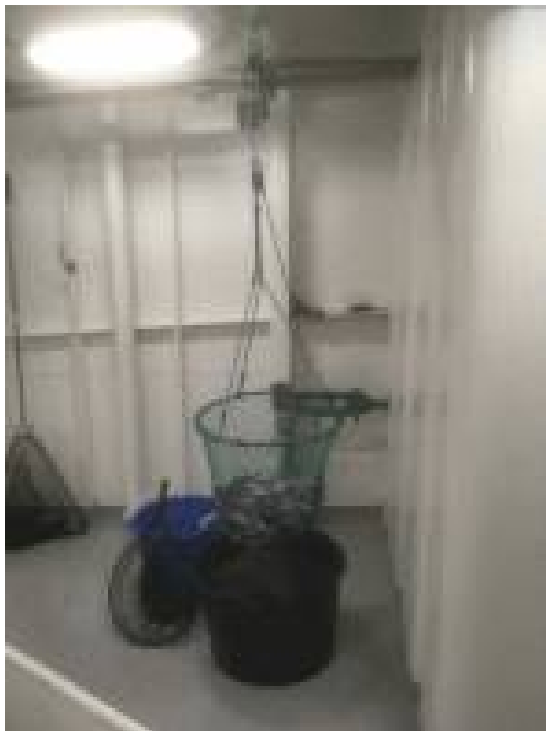
Figure 10.1 – Rig for weighing fish samples in air and in seawater, with the fish held in a net bag supporting by a steel ring.

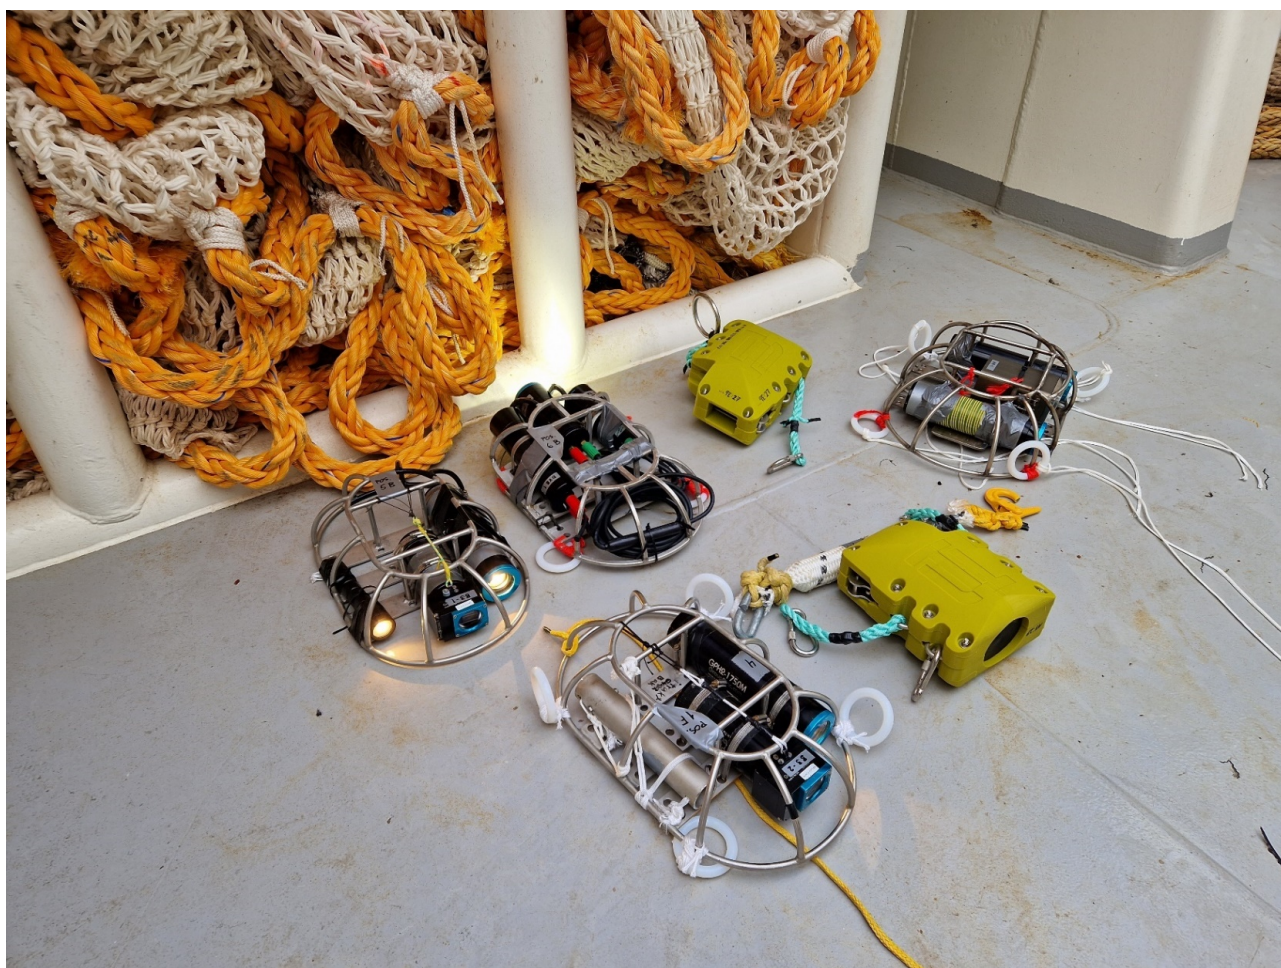
Figure A1 – various camera systems and other instruments ready for deployment before Test haul #T2: top left, GoPro cameras (in a B-group housing) in a protective steel “dome-frame”, with two white lights; top centre a FossTech Codend Choker Unit (CCU); top right, the “DarkVision” camera system in a “dome-frame”; centre right, a removal depth sensor and backup CCU; and bottom centre, a GoPro Hero 5 (in a B-group housing) in a “dome-frame”, with one white light and a depth sensor, for monitoring the CCU opening time and depth.
