# CRUISE REPORT 2022106

MAREANO methods cruise: AUV testing (Munin +)

TOKTRAPPORT  
No.6 2023

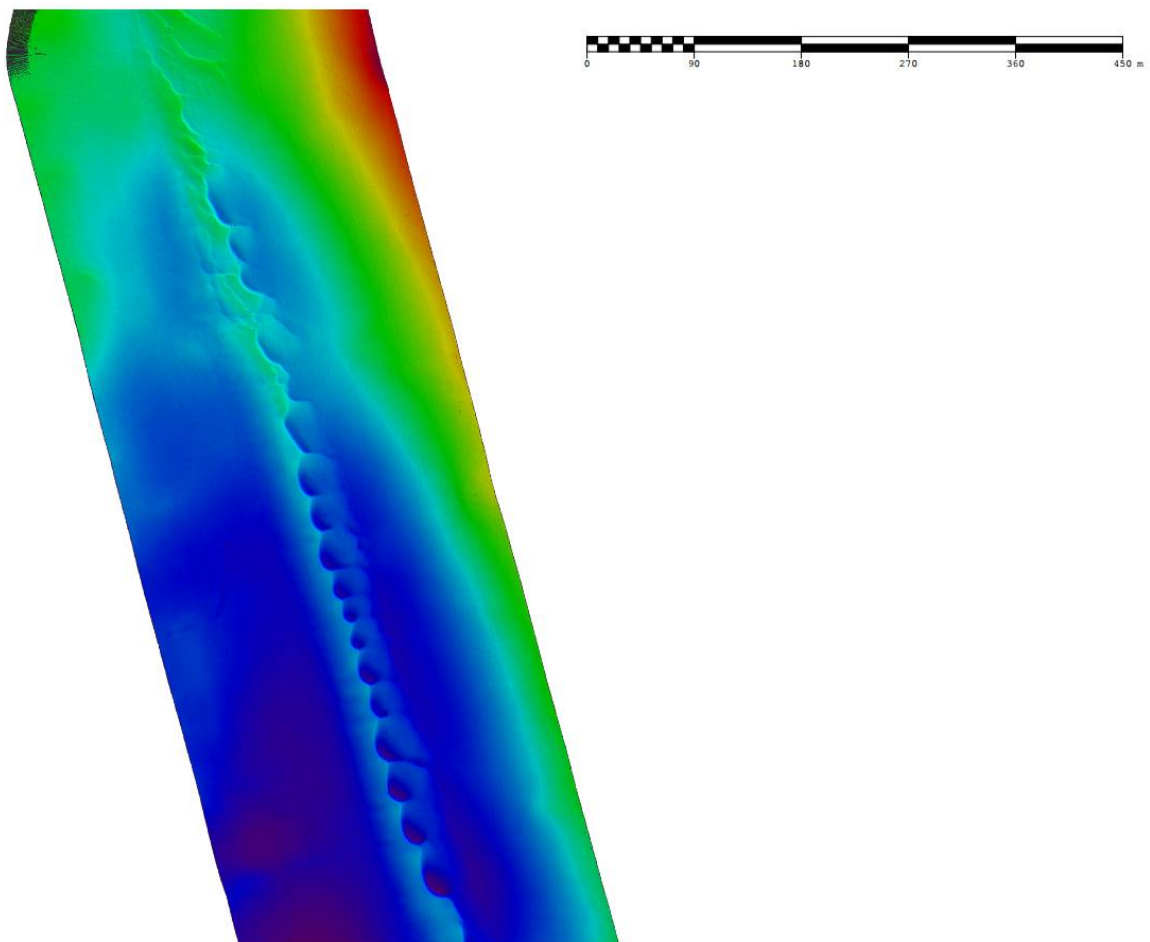
*Image shows multibeam bathymetry from AUV Møre (Mission 55 20220606 2) and the sand wave feature at the start of the dive, processed in Caris by Tor Jan Meek.*

At the Tromsø test site there was an issue with an average 20cm difference in depth between overlapping swaths, with the photo lines (up /down slope) showing 20-50cm discrepancy. However this seems to have resolved at subsequent sites without any action taken. Apart from the problems at the Tromsø test site, the MBE data so far has been of very good quality. The MBE data from Mørebanken is much more consistent and of very good quality. Hardly any noise, just a few outliers which is expected, but no “real noise”, no visible sound velocity error, no visible position drift and less than 10cm depth difference between survey lines.

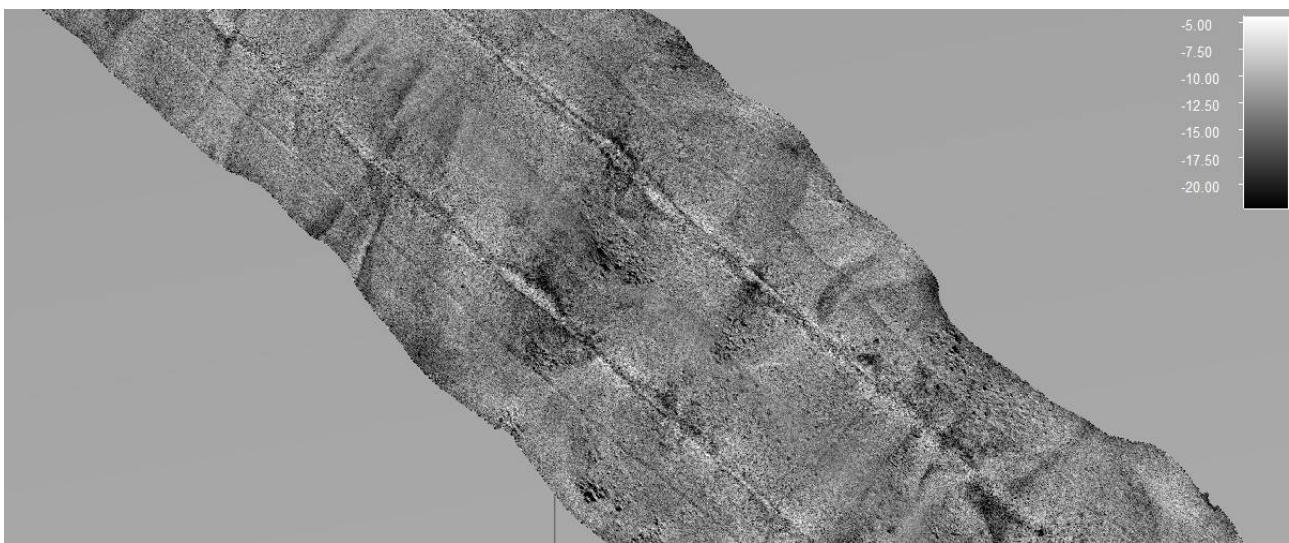
*Example NGU processed backscatter data (FMGT) from AUVMøre\_VL1293 (Mission 55 20220606) showing along track striping (sector problems?)*

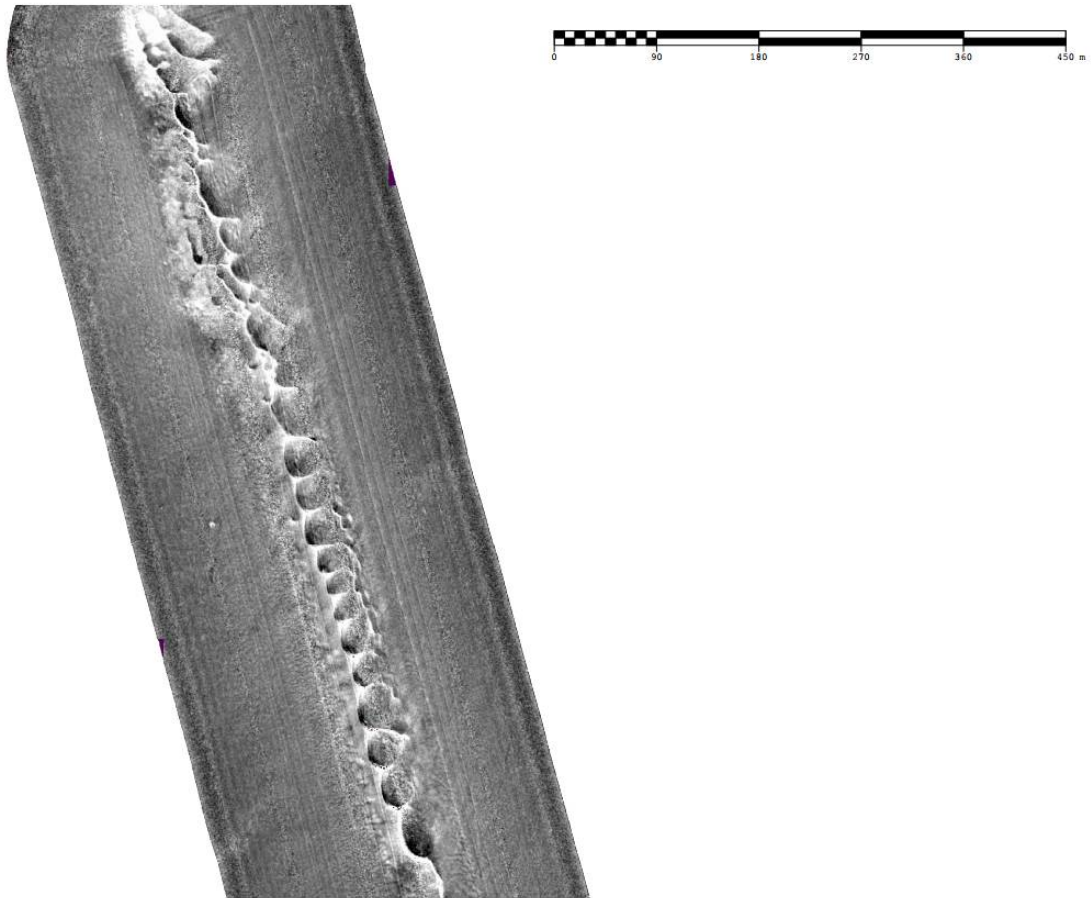
*Example Kartverket (CARIS) processed backscatter from AUV Møre (Mission 55 20220606 2) and the sand wave feature at the start of the dive*

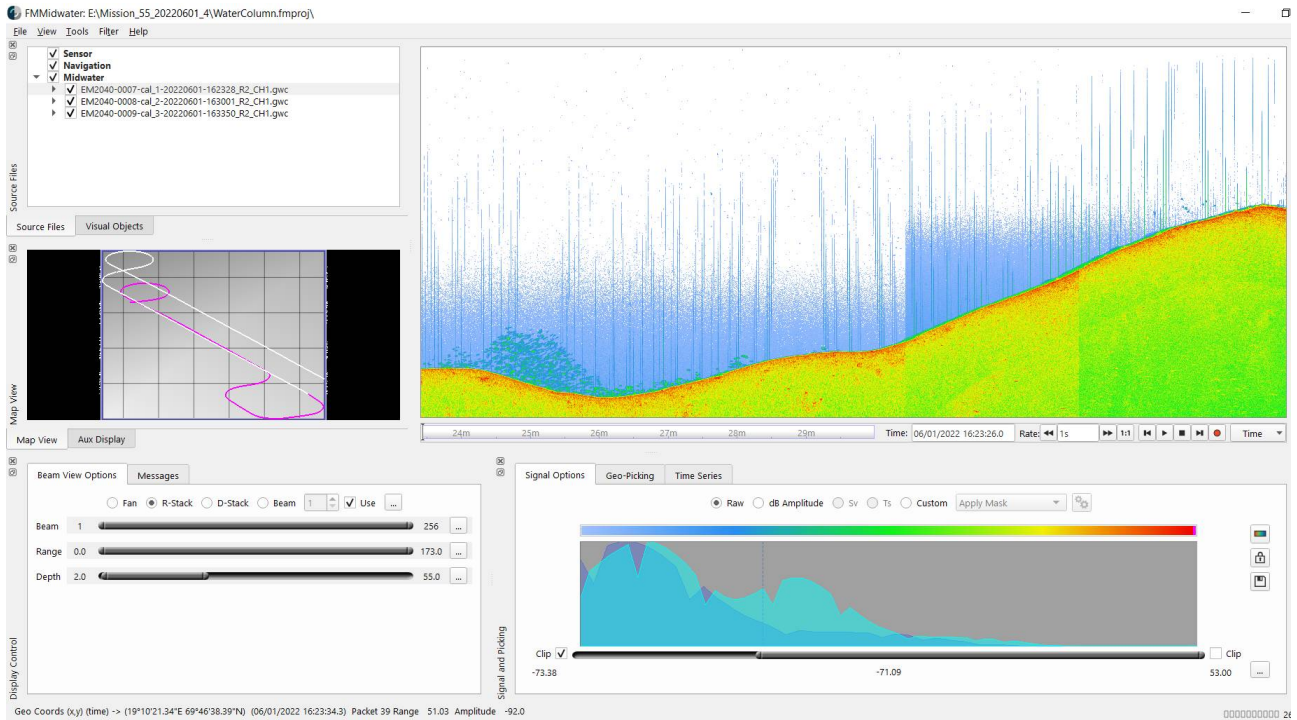
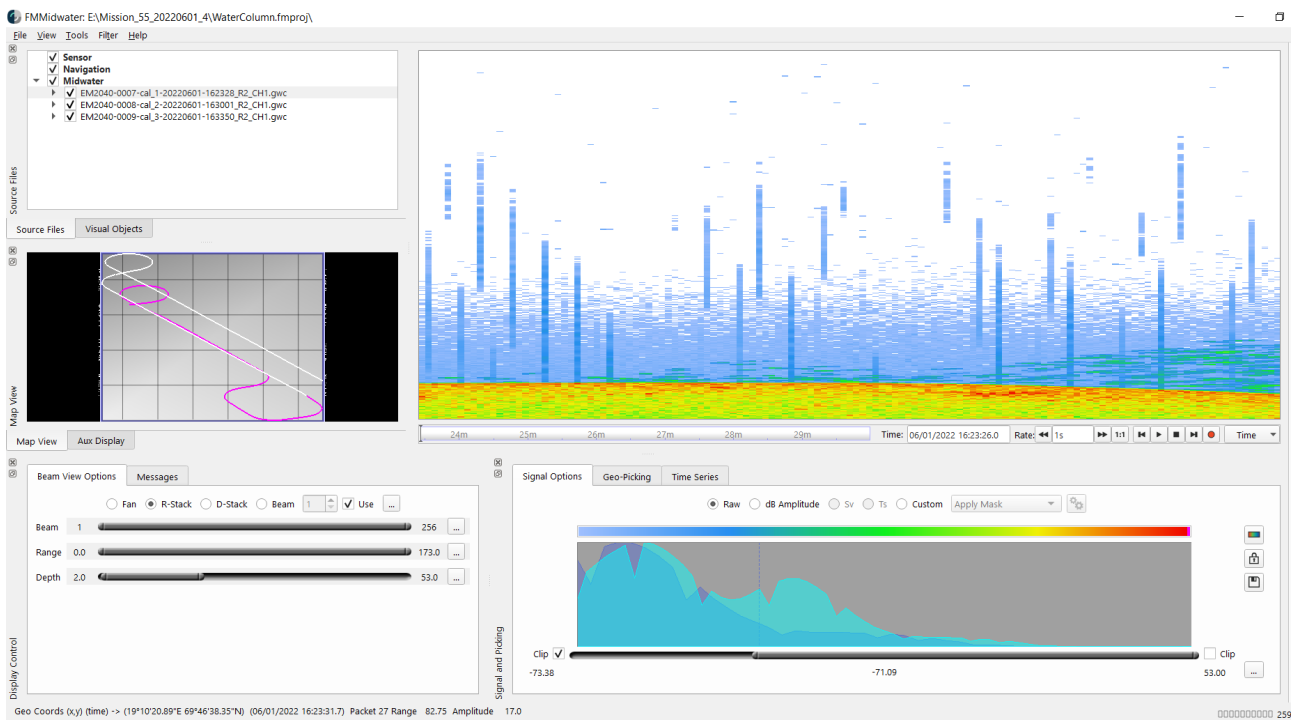
Example data from test area Tromsø – noise appears as vertical striping.

Water column data is fine but interference from other systems were noticed. More testing is needed to single out the noise sources and efficiently avoid them.

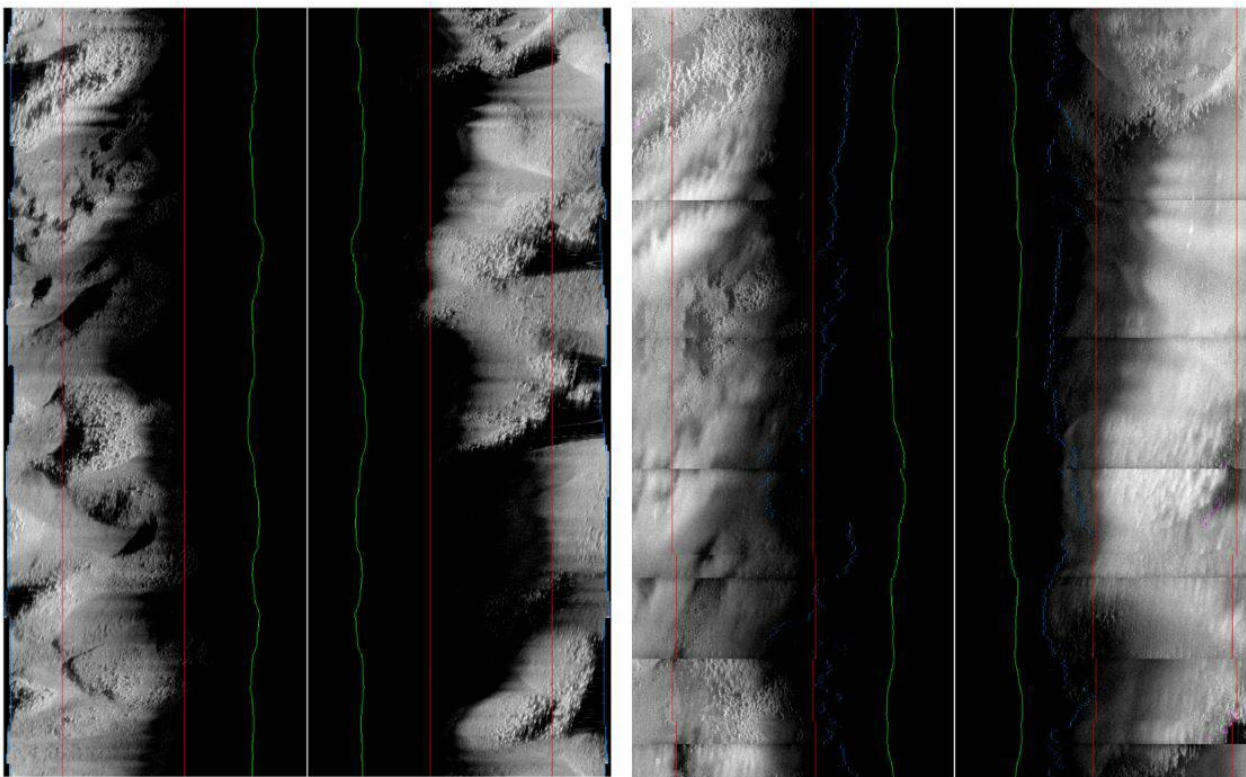
*Comparison between the “sss” (left) and “HiSAS imagery” (right). The resolution of the sss-data is low, but the data is consistent, while the resolution of the HiSAS is high but the consistency is poor.*

The HiSAS imagery as seen after the on-board processing was not as good as expected. The processing algorithm seemed to struggle to display the data correctly in the Reflection software. As seen on the figure, the resolution of the data is impressive, but the dataset is severely obscured by some sort of artificial striping perpendicular to the flying direction. The sharp stripes occur on the border between the individual sas-files (each <100 MB), but blurry lines are related to the processing algorithm. Part of the reason of this is believed to be a software issue and it is believed that the quality of the data will be much better after proper processing, but it is likely that as we gain more experience and are able to plan HiSAS surveys in more detail that this will also improve the results. The HiSAS processing algorithm favours a flat seabed, and the instrument is very susceptible to “pitch” and “crab”.

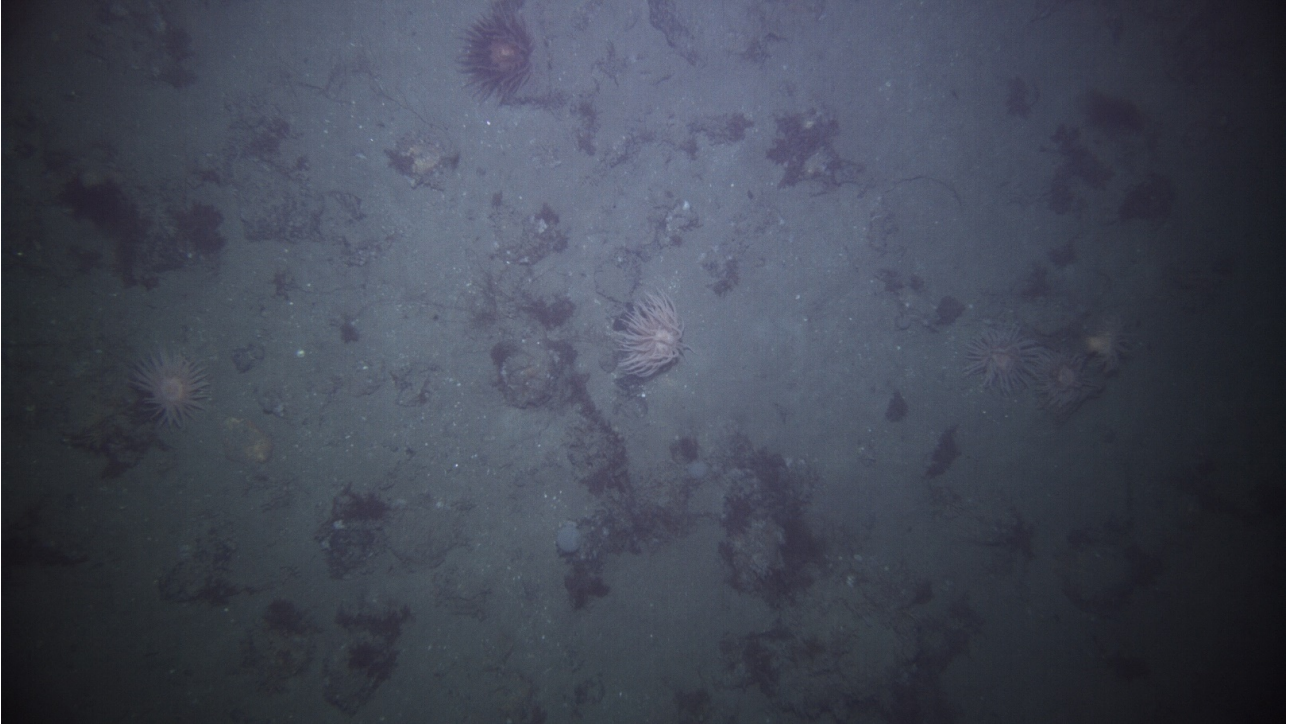
*Example photo from 5m altitude at the test site (unedited)*

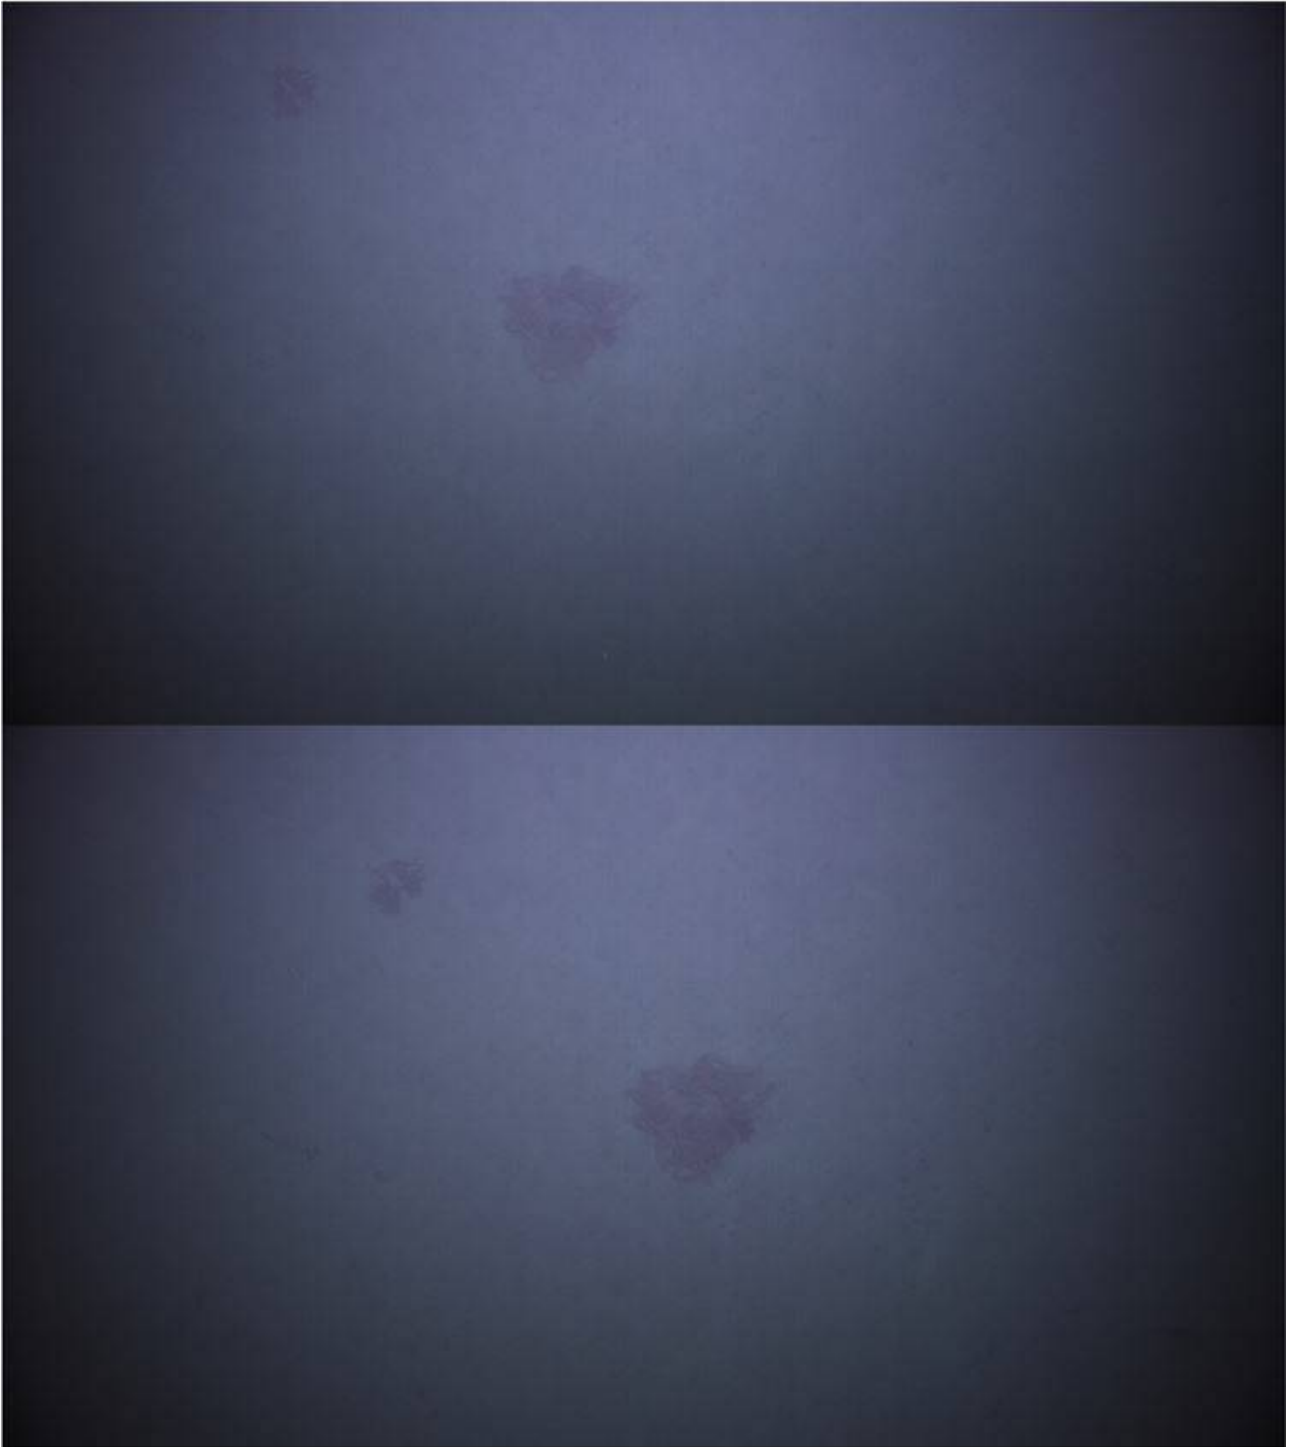
*Example photos from the AUV: testing heights - a discarded chain at the test site is visible in both 6m (top) and 5m altitude photos (bottom) – both are unedited.*

Photo lines have been tested successfully at 6m, 5m and 4m altitude, although note that despite having 4m altitude set at AUVMøre the rough terrain of the coral reef on a slope meant that the AUV did get to within 2.6m of the bottom at one point before recovering and re-gaining the programmed 4m altitude. Lower altitudes are therefore not recommended on rough terrain, but could be possible on flat sediment bottoms.

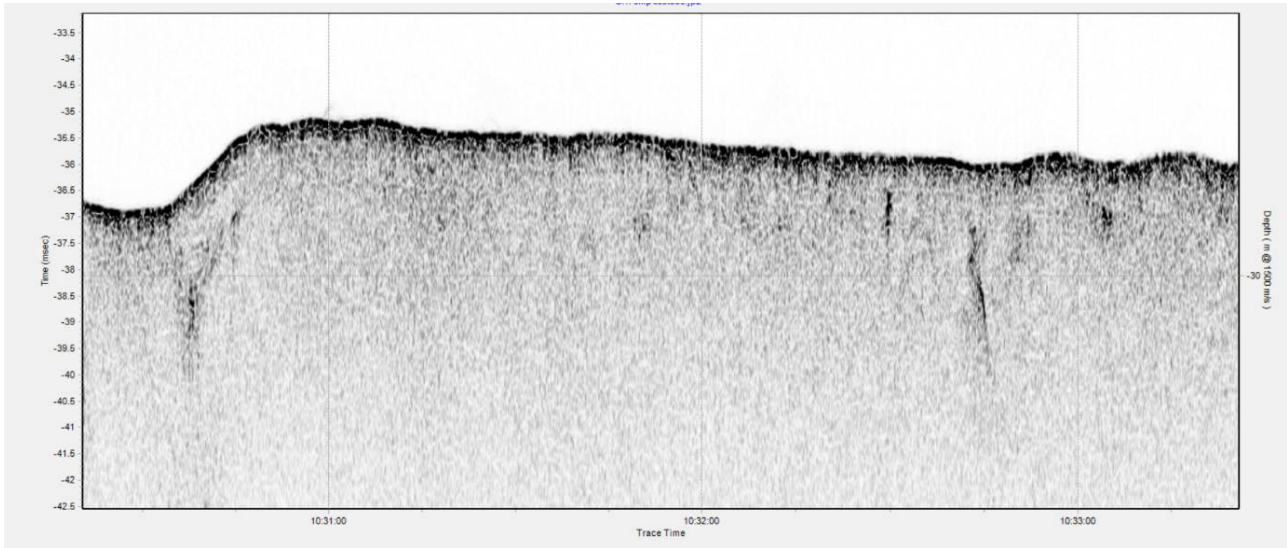
*Example sub bottom profiler data from AUVMøre VL1071*

SBP data looks fine, but the areas investigated do not have much stratigraphy to check the penetration capabilities. Further testing is necessary.

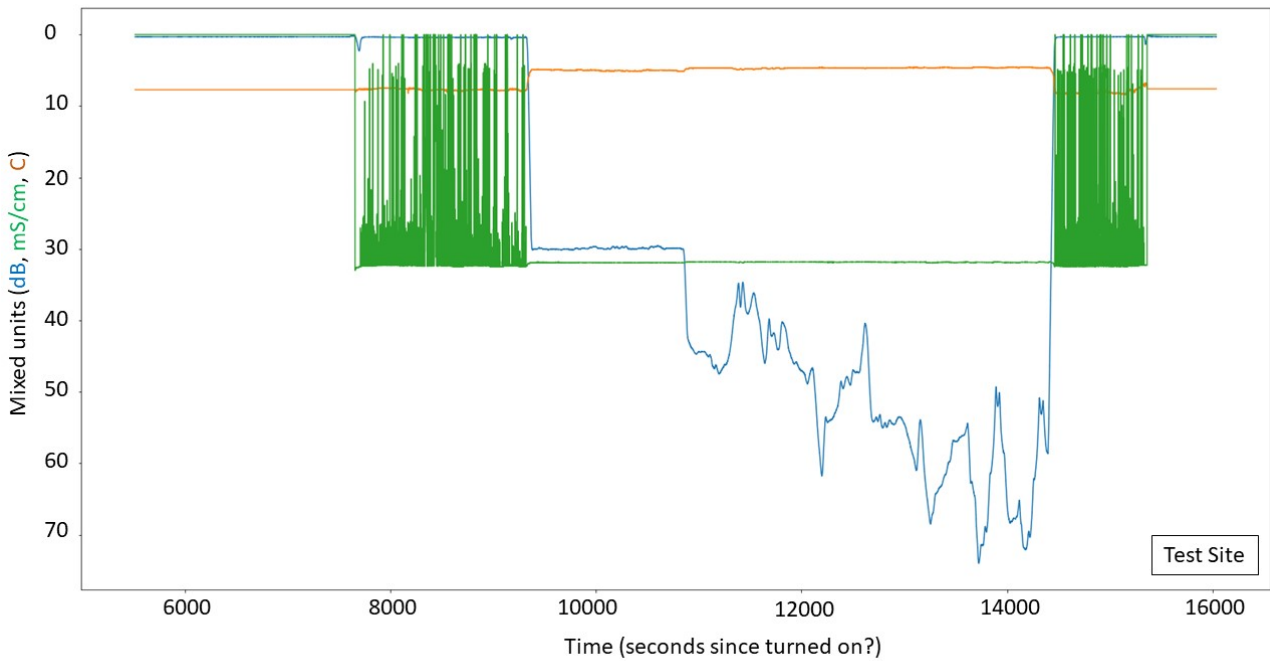
Overview CTD graph from the test site: Blue line: pressure (dB), green line: conductivity (mS/cm), orange line: temperature (C). The units are not specified in the files and are to be considered as reasonable assumptions. The x-axis is time, in mystery units. It might fit with seconds since the AUV was turned on. The "forests" in the conductivity data corresponds to time the AUV was spending in the sea, but on the surface, where the CT sensor was bobbing in and out of the water.

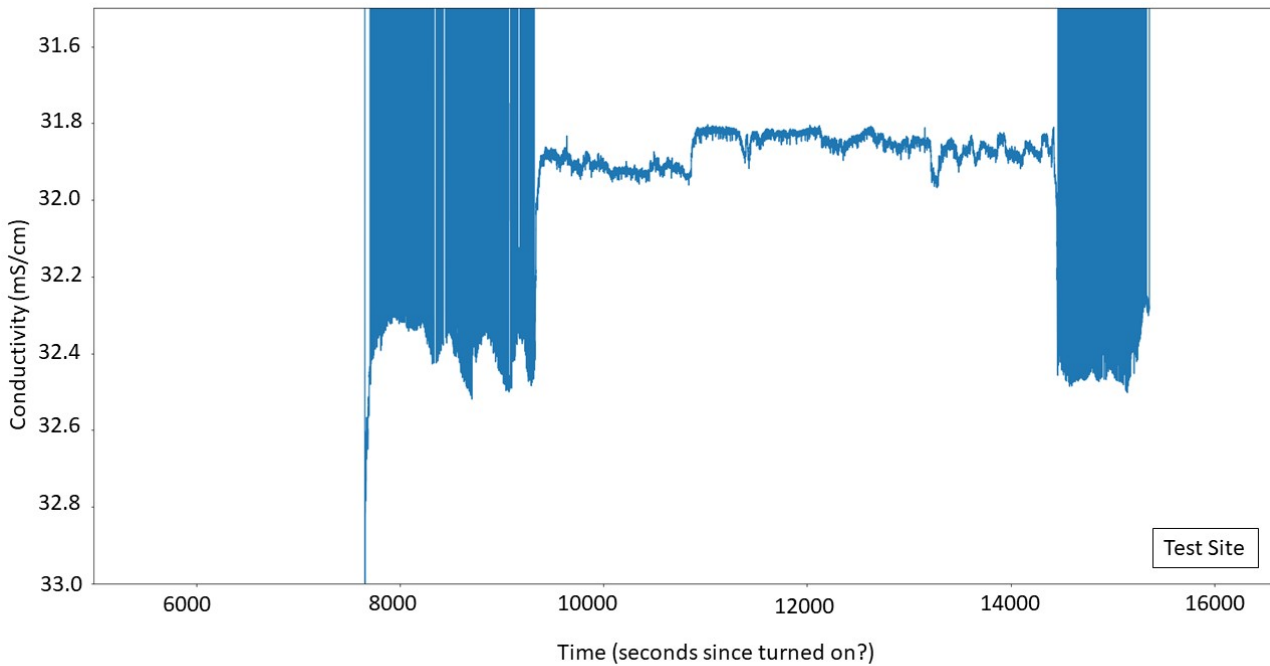
Conductivity versus time, zoomed in to show variation.

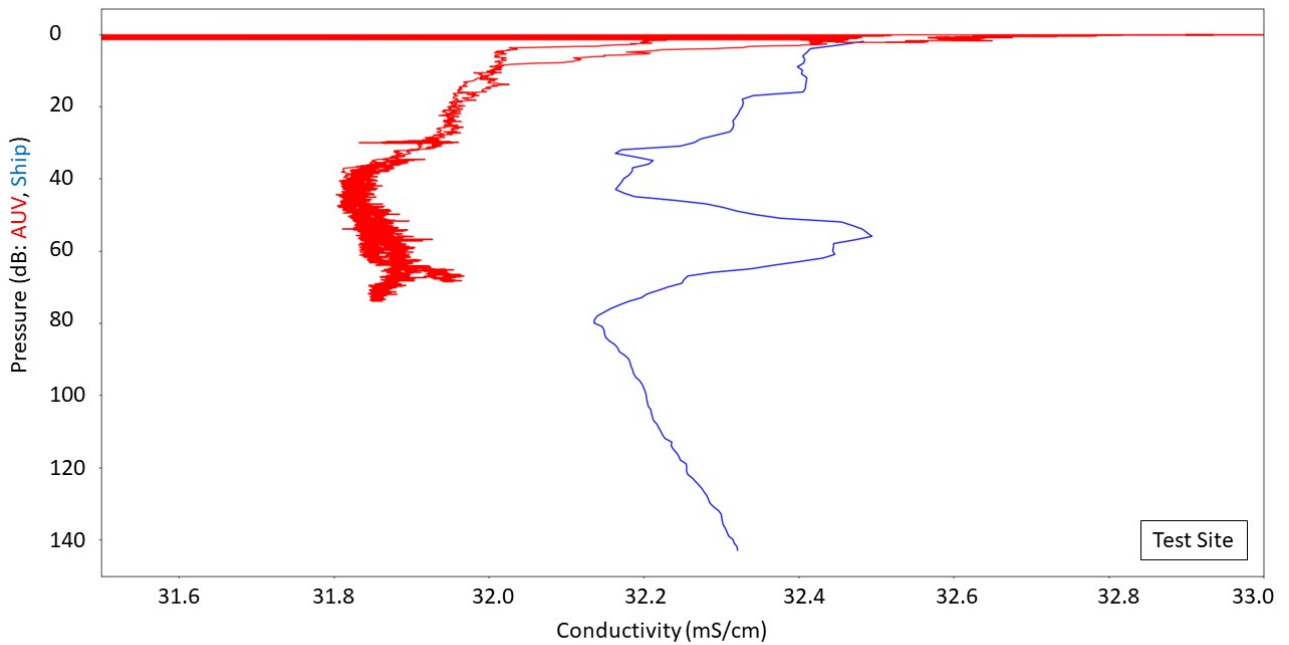
*Comparison between shipborne and AUV conductivity. The shipborne CTD was taken in a deeper area slightly off the site. The ship CTD uses S/m units of conductivity – these have been multiplied with 10 to match the units from the AUV. The most glaring difference is an offset of about 1%. In the upper part of the water column, the profiles otherwise reproduce the general shape of the profile, and the spike at 30m depth. The thick part of the AUV graph corresponds to the AUV moving near the bottom, covering an extended area with varying depth. The shape of the profile here does not match that of the shipborne CTD well, but since the AUV test area is in a strait and, and the CTD station in deeper water, this might be due to real differences in the water properties.*

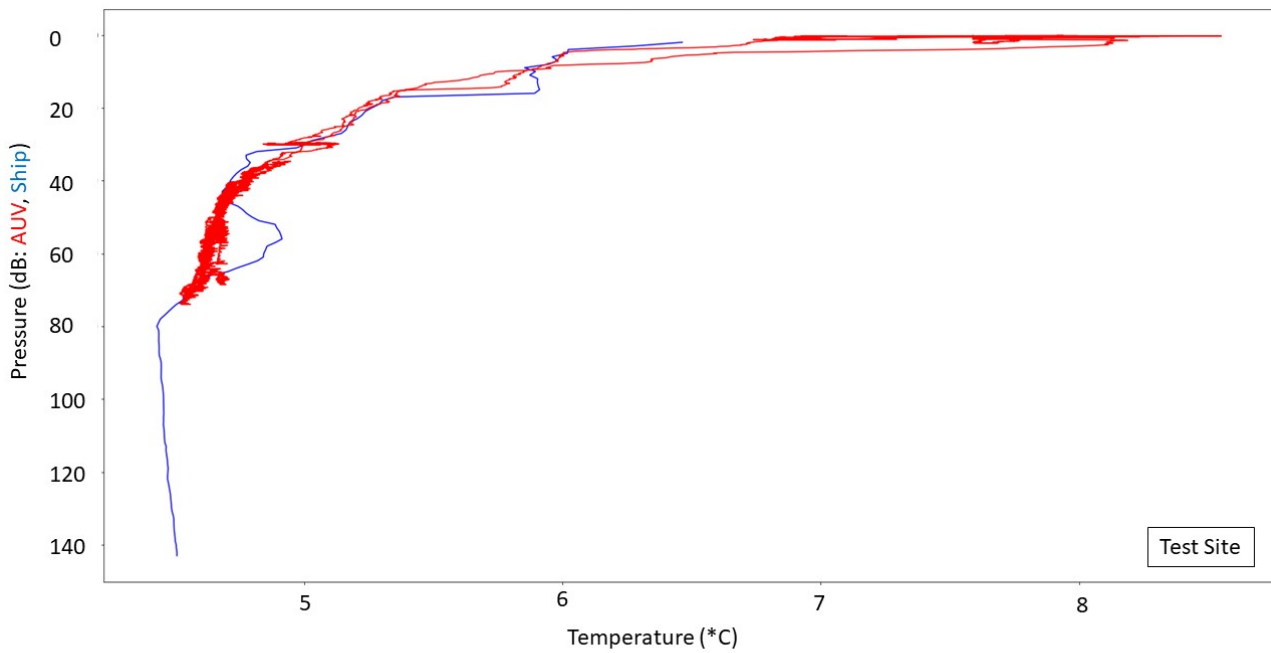
*Comparison between shipborne and AUV temperature. The shipborne CTD was taken in a deeper area slightly off the site. Overall, the match is reasonable in the upper part of the water column. The feature in the shipborne CTD at 45-70m is not reproduced in the temperature profile either, but more resembles the AUV conductivity profile above. While the cause is unknown, it lends support to the hypothesis that the water properties really are different in the shallow and deeper areas.*

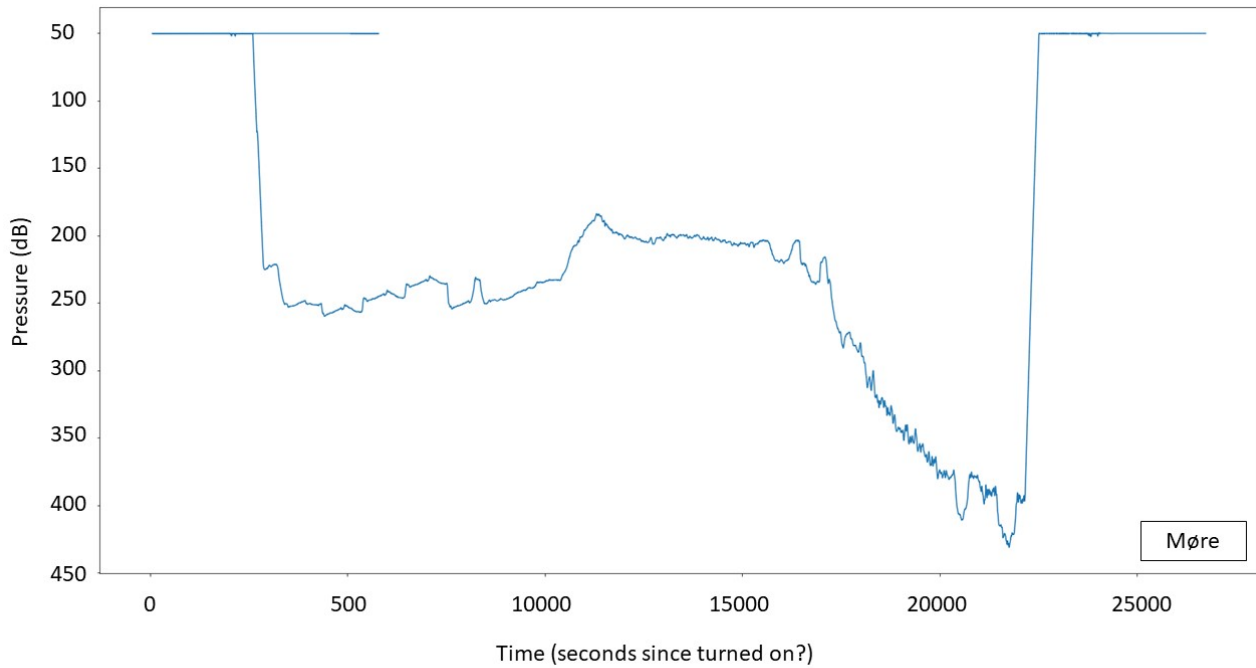
Depth (pressure) over time. The AUV was deployed on the shelf and did a couple of “mow the lawn” areas on the shelf before transiting down the slope to the final “mow the lawn” at a deeper level.

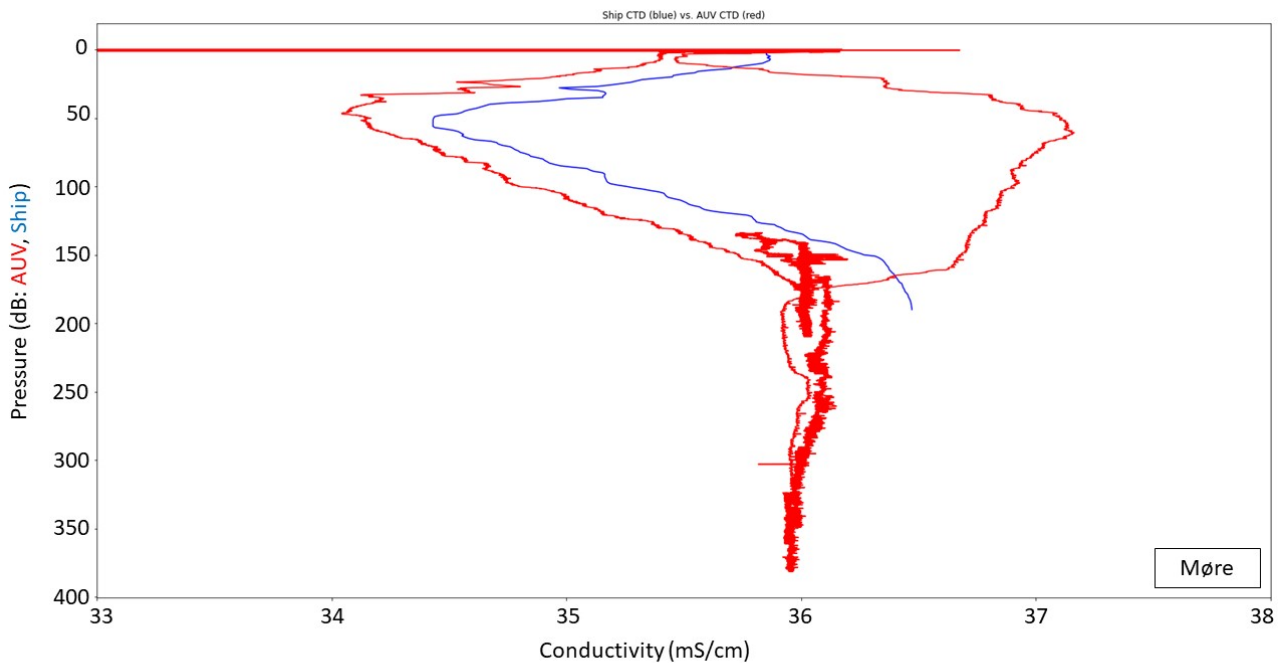
Comparison between shipborne and AUV conductivity. The shipborne CTD was taken on the shelf where the AUV was deployed. The ship CTD uses S/m units of conductivity – these have been multiplied by 10 to match the units from the AUV. Very apparent is an offset between the ship and AUV conductivity of about 1%. On the shelf, the profiles otherwise show a good correspondence. The shipborne CTD shows only downcast, while the AUV CT show both down- and upcast. The water properties are notably different on and off the shelf.

A possible reason for the conductivity offset could be that the AUV conductivity tube is contaminated with a coating of something, e.g. grease. After the Møre mission, the technicians cleaned the CT sensor with Triton X. Unfortunately, we did not manage to complete any further dives. {if the "and a bit" dive have any CT data, we can compare}

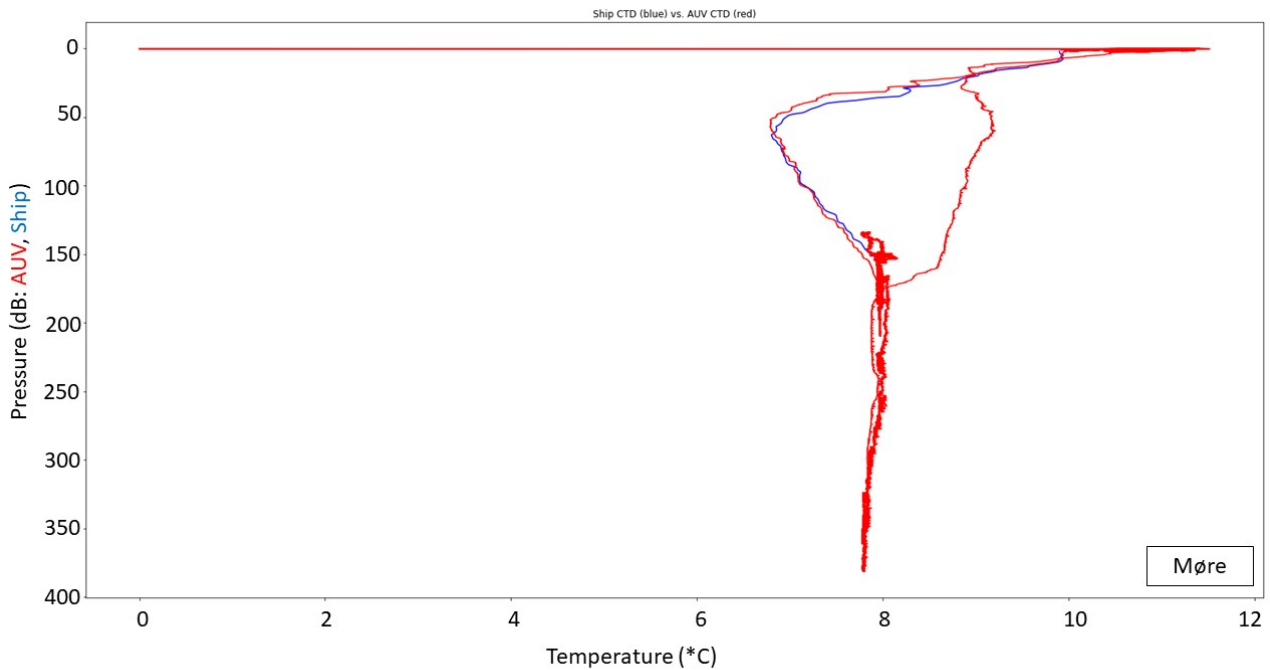
*Comparison between ship and AUV temperature. The downcasts follow each other well, but it is possible that there is a small offset of some kind. It is also possible the difference is due to natural variation and a (small) difference in position and time of the two casts.*

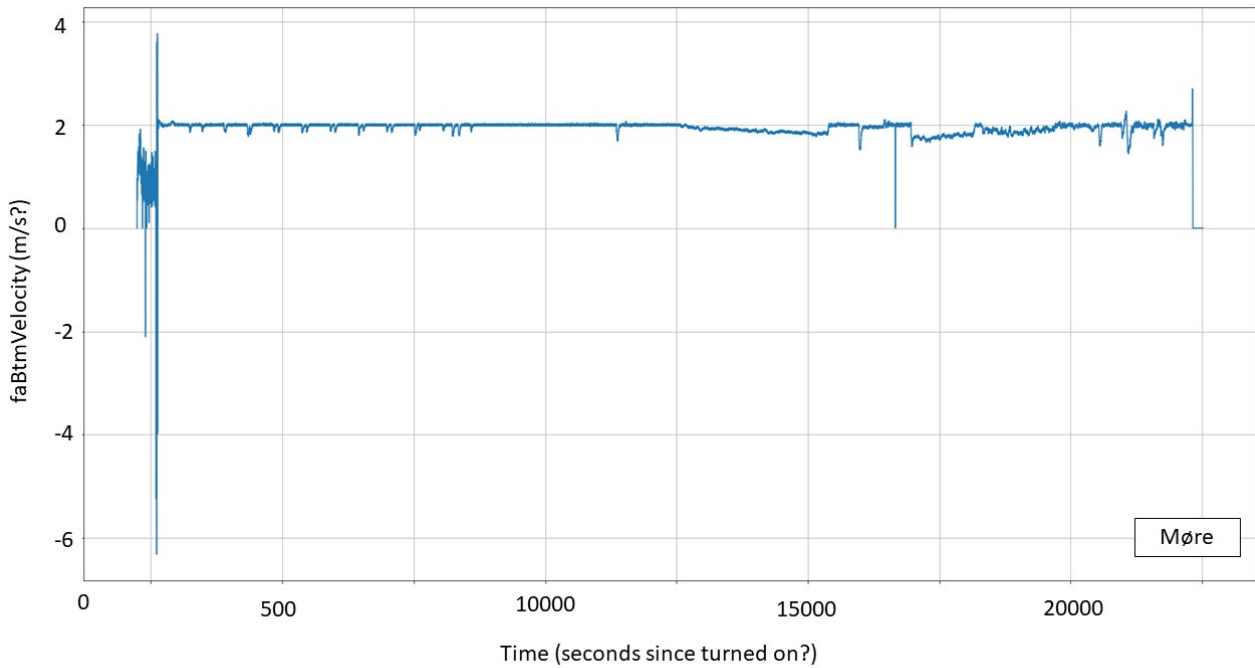
*faBtmVelocity vs. time, assumed to be the bottom track velocity in the along-AUV direction. The velocity of about 2m/s(?) corresponds to the AUV speed of 4kn.*

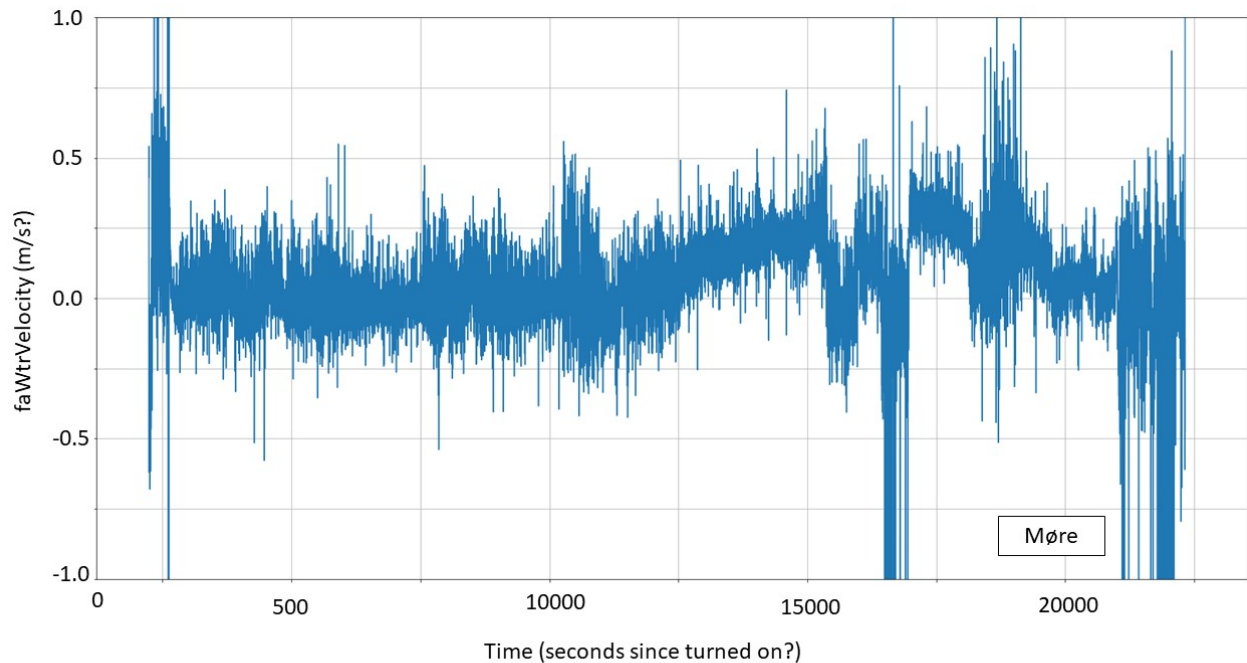
*The parameter faWtrVelocity, assumed to be speed through water in the along-AUV direction, is very similar to faBtmVelocity. Subtracting faBtmVelocity from faWtrVelocity gives the above plot, with residual velocities. The magnitude of the residual current is within expectations from the shelf slope (up to  $-0.70$  m/s).*

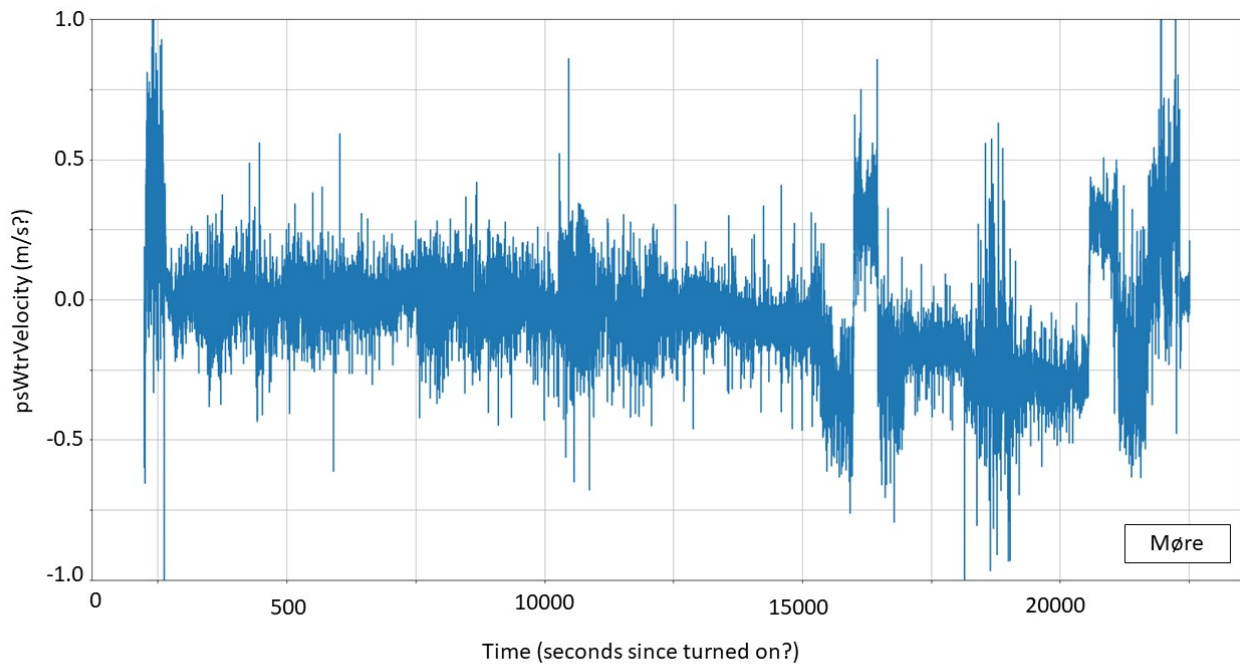
*Above plot is  $psWtrVelocity - psBtmVelocity$  (i.e. residual currents in the cross AUV direction). Again the magnitude of the current is plausible. The AUV descended the slope at an angle, so we would expect the slope current to be split between along- and across-AUV directions.*

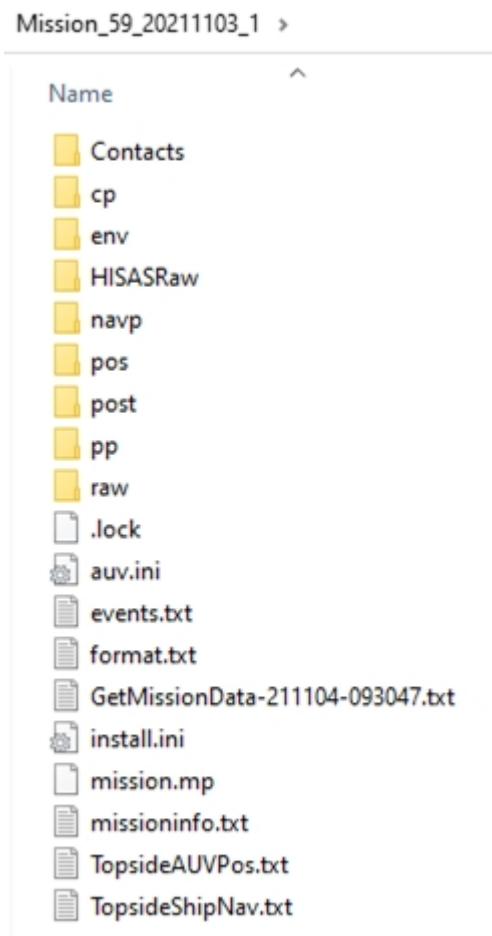
*screenshot of a typical mission folder structure*

NB The format file is useful for finding headers for any of the sensor data.

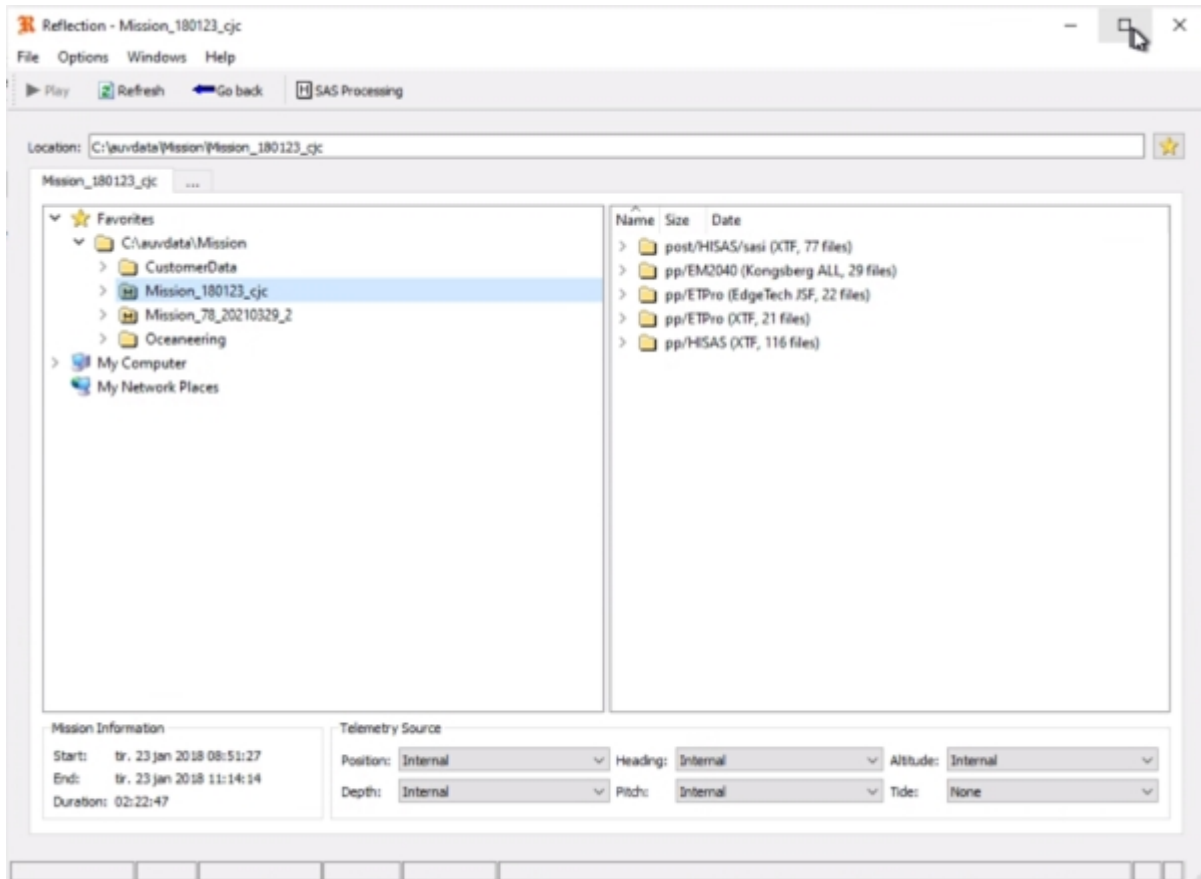
*Screenshot of Reflection's file selection window - the start point when trying to view AUV data*

Within subfolders you can select file to visualise and you can use the dropdown menus at the bottom to modify various options e.g. whether you used processed or unprocessed navigation data. You will then press play to view the data and are automatically shown the right type of viewer for that data.

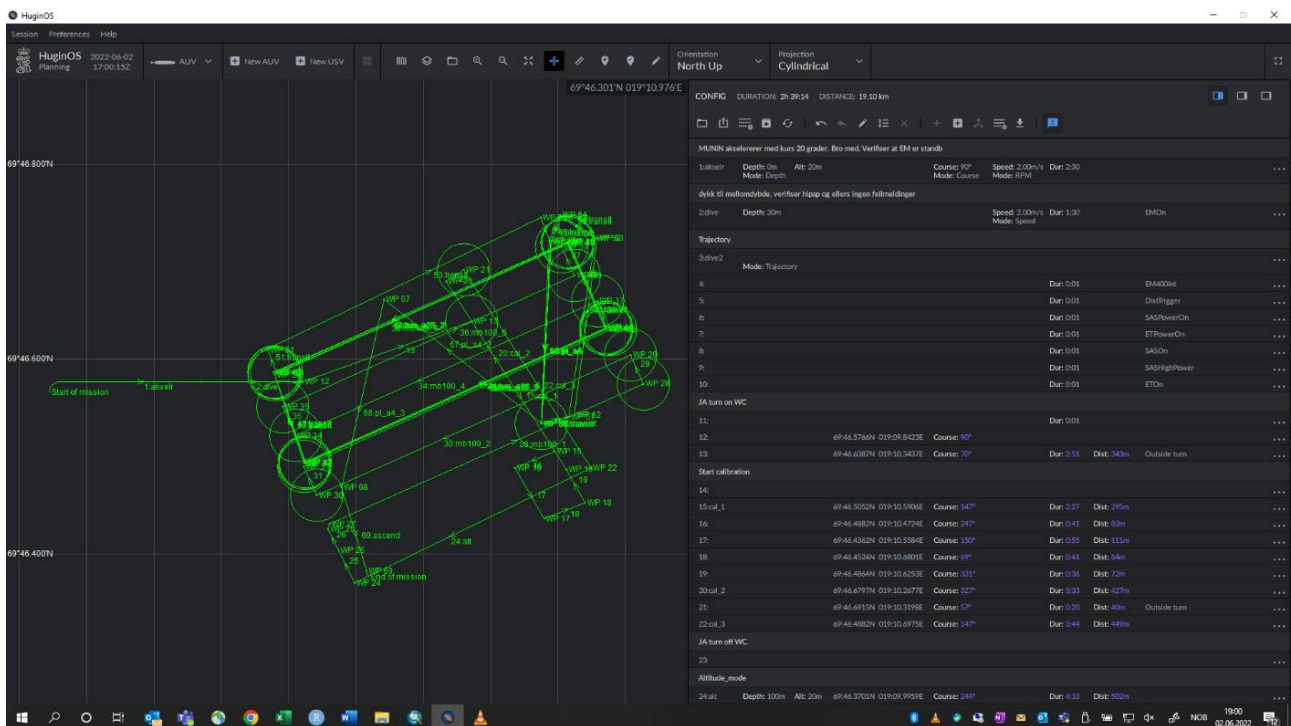
Screenshot of HuginOS and the planned dive track and instructions for the test site
