# CRUISE REPORT 2022106

MAREANO methods cruise: AUV testing (Munin +)

TOKTRAPPORT  
No.6 2023

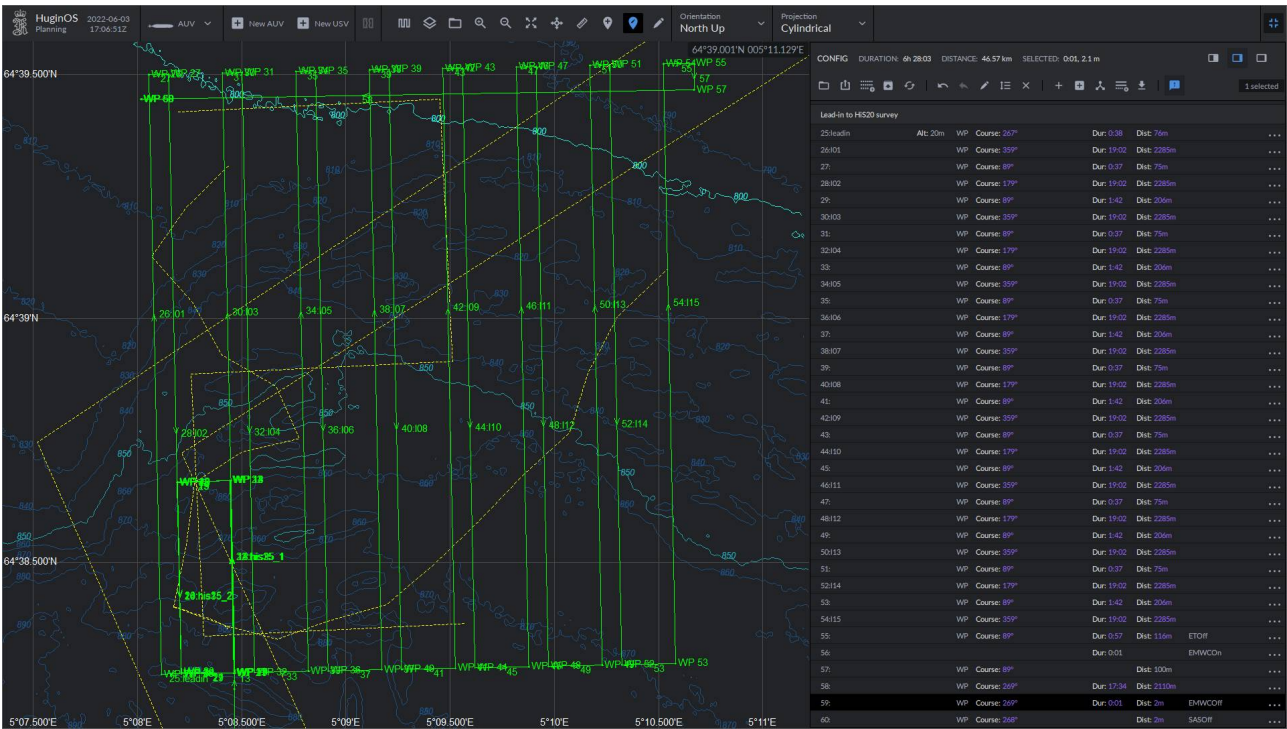
HuginOS screenshot of AUV6 dive plan

In the meantime, we have planned dives at AUV6 and AUVT1. AUV6 now includes 4 heights of HiSAS around a circuit that is ~700m x 300m and mapped over the video line for groundtruthing to provide the heights test that we have not managed to do at the previous 2 sites. Then the rest of the site is in mow-the-lawn pattern for 100% HiSAS coverage with 20m height, followed by a crossline where SBP is switched off and water column MBE is turned on (assuming that it was SBP that interfered with the watercolumn at the test site). This will allow a test of WC over soft bottom. One VL is covered in this area, together with the two 5km template photo dive patterns proposed by Jackson Shields and Oscar Pizarro. An expert-led 5km rout will also be added to the photodive after evaluating the features seen in the acoustics. The acoustic dive should be 6.5hrs long. AUVT1 is planned to follow the turning route that captures multiple video lines and bisects multiple planned boxes/features and climbs several slopes of varying degree to test how the AUV handles this (including in the edge of AUV6 which was reduced in size to accommodate time constraints). The height of acquisition will be decided after the AUV6 results.

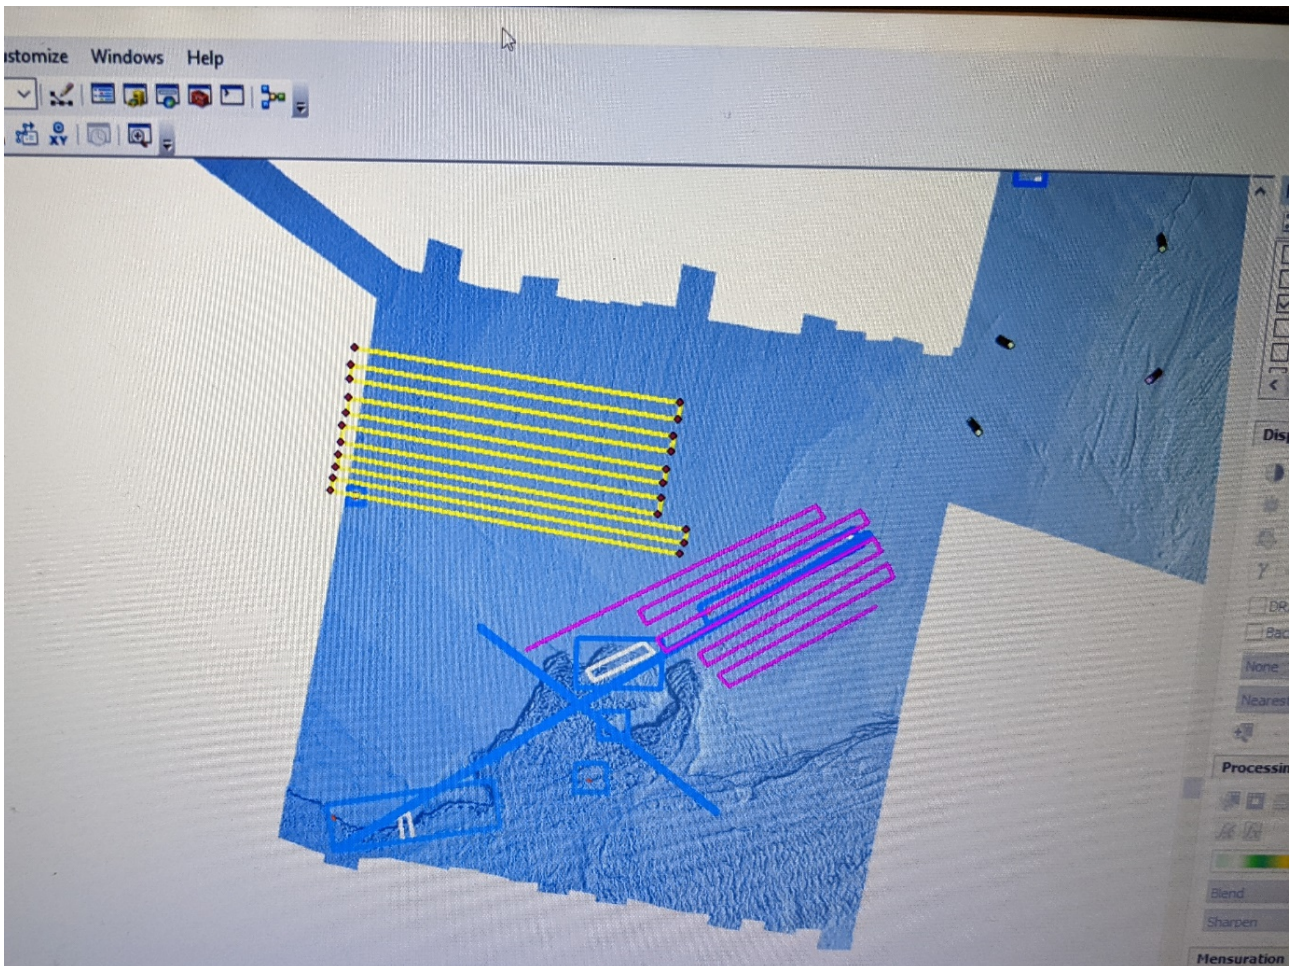
*Planned SBP/WC MBE surveys in pink (the first) and yellow (the second)*

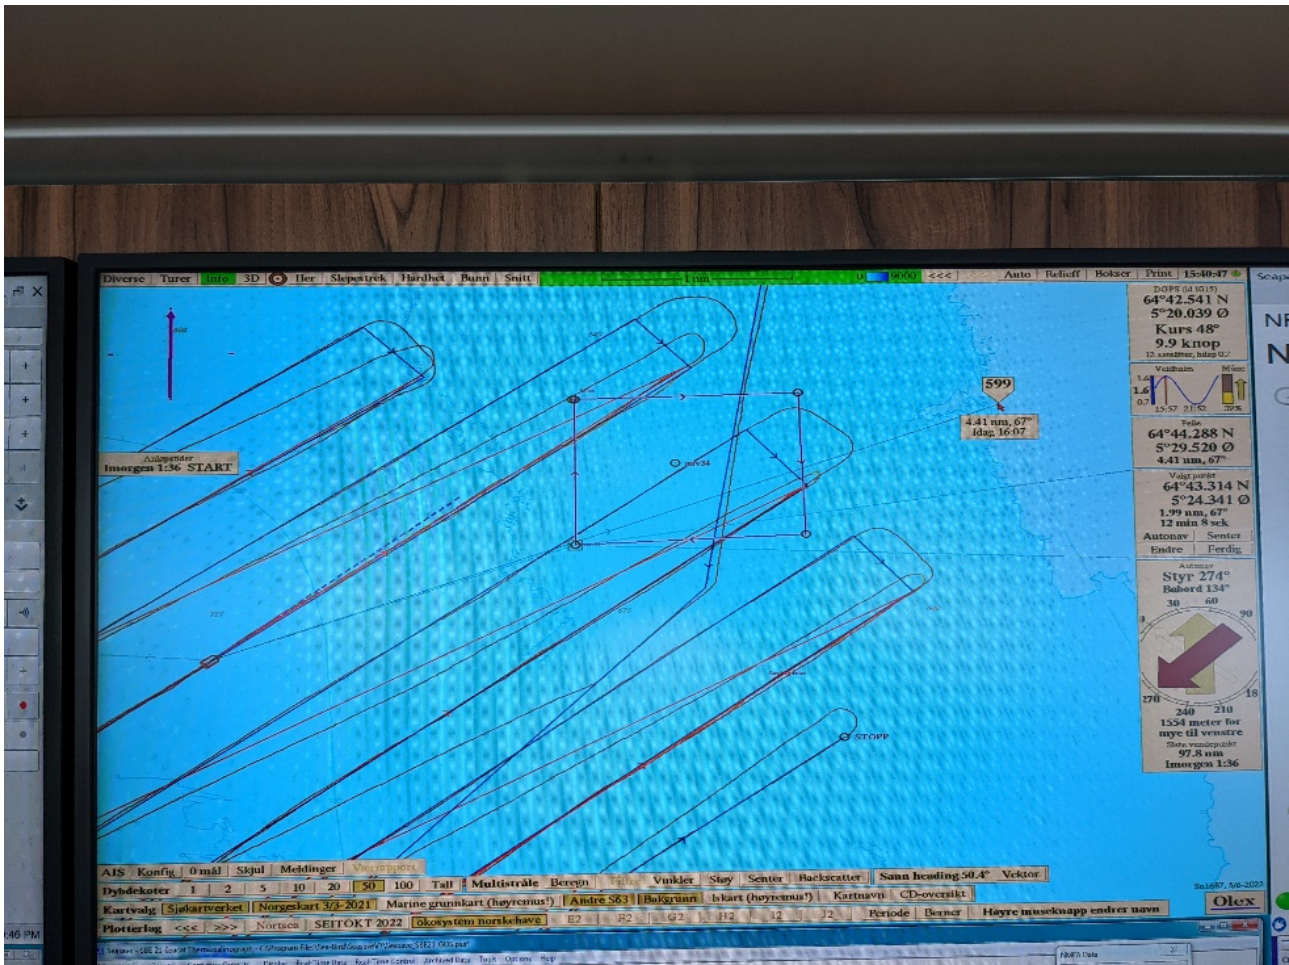
Olex screen showing planned SBP lines and the square around AUV34

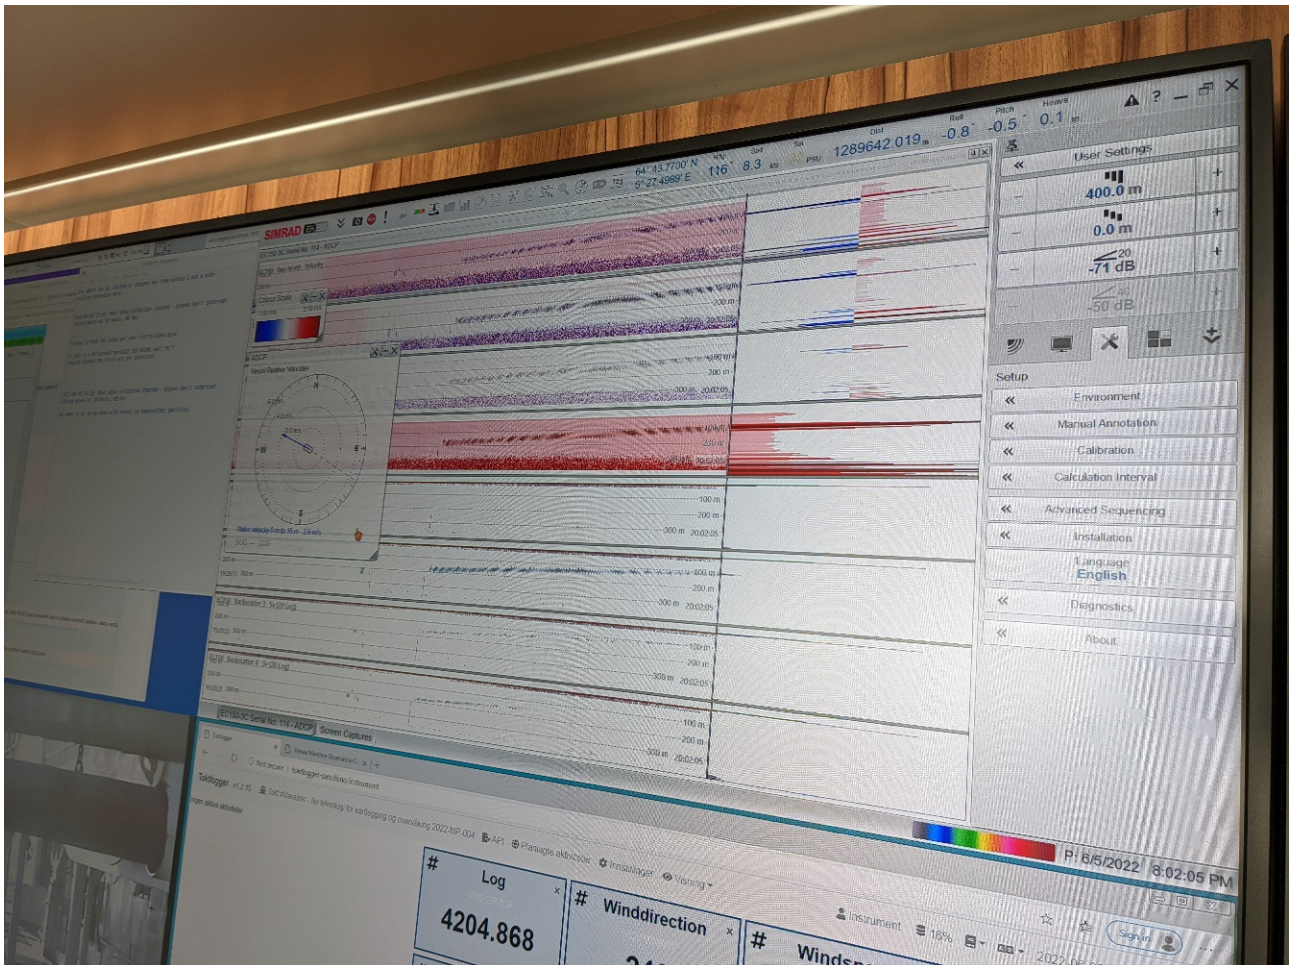
*Limited backscatter in the water is reducing ADCP effectiveness in this area*
